# C1: Topography and hydrology monitoring

*LIFE16 ENV/ES/000159*

[December2023]

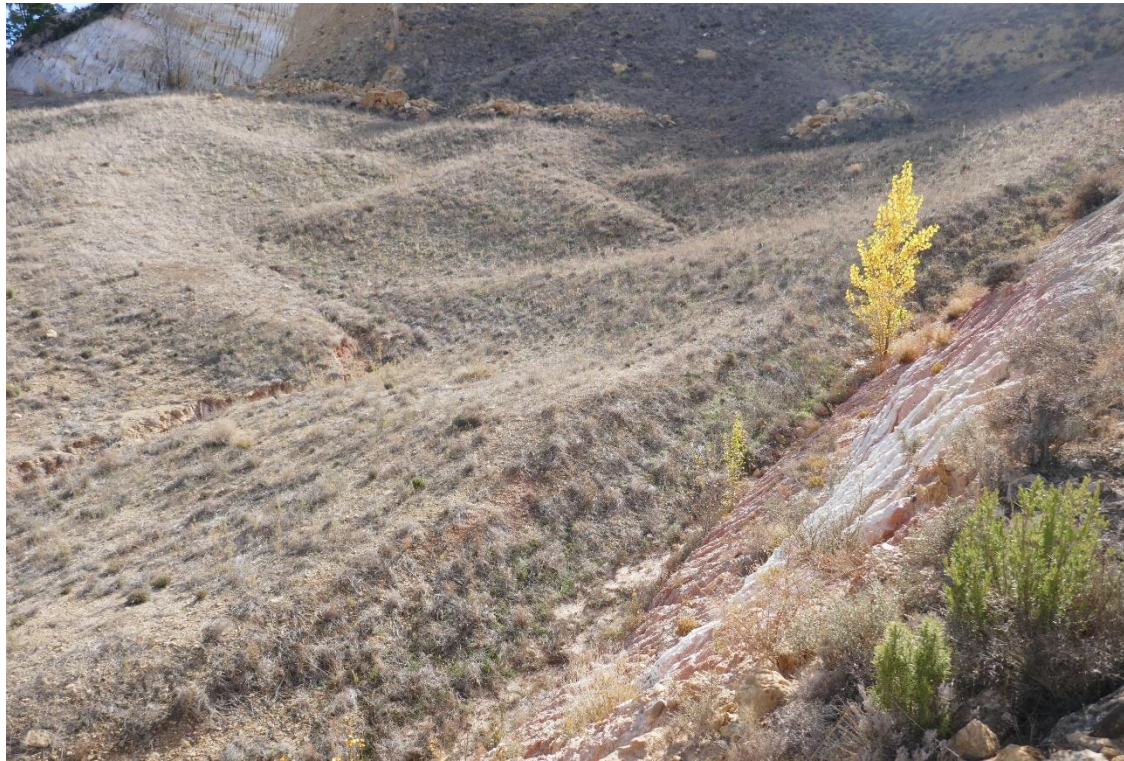
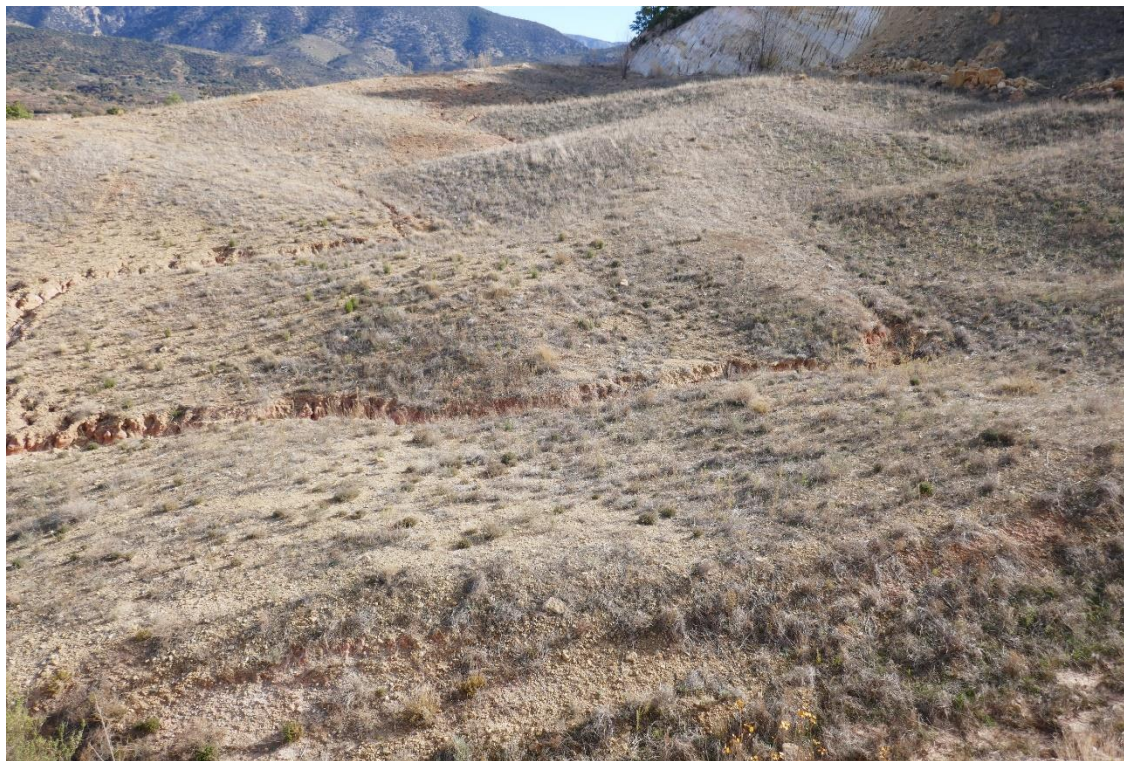
- Eastern GeoFluv (=Conventional GeoFluv without tree holes): no rill networks had been developed in 2021. No rills have been found in 2023 either, as shown in the figure 1.

Figure 1. Panoramic view of Eastern GeoFluv (=Conventional GeoFluv without tree holes) in 06.12.2023. No rill system has developed and vegetation is not limited by erosion. The photo above is of the western side and the photo below is of the eastern side.

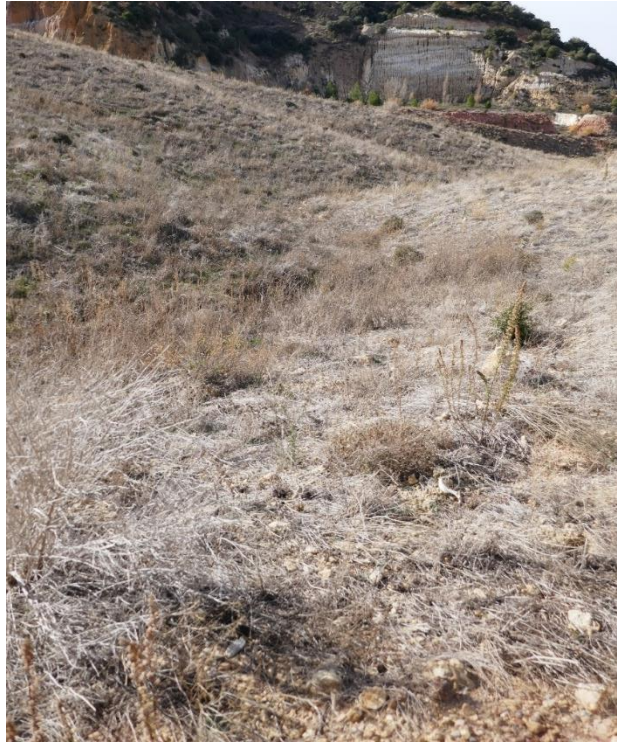
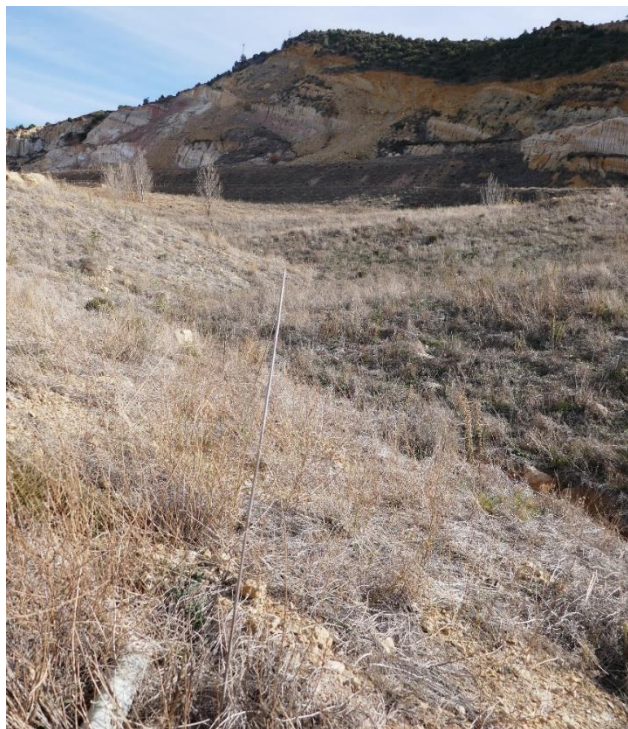
- Western GeoFluv, "Conventional GeoFluv with tree holes": Rill network was underdeveloped in 2021 (rill density: 0.16 m/m<sup>2</sup>). Photographs and field observations indicate that the rills have become non-functional in some areas as vegetation has developed. No new rills have been developed. See figures 2 and 3.

Figure 2. Panoramic view of Western GeoFluv “Conventional GeoFluv with tree holes” in 06.12.2023. Photographs and field observations indicate that the rills have become non-functional in some areas as vegetation has developed. No new rills have been developed. The photograph above corresponds to the lower part of the basin and the one below to the upper part.

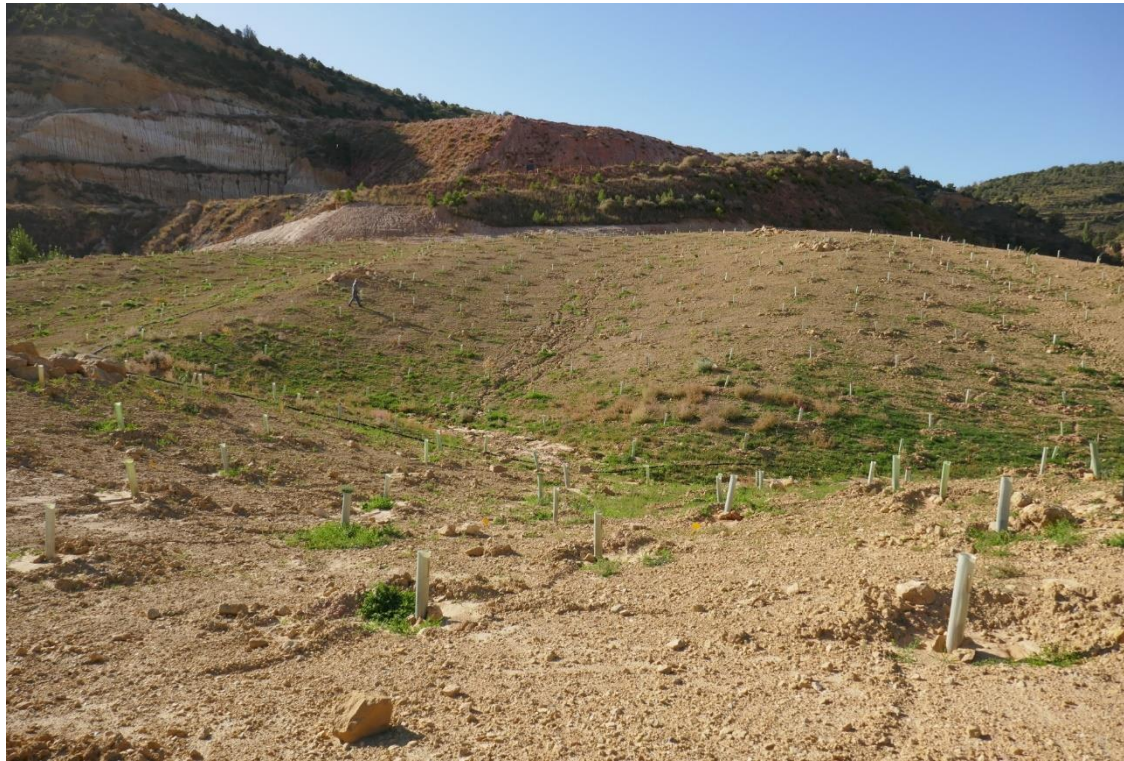
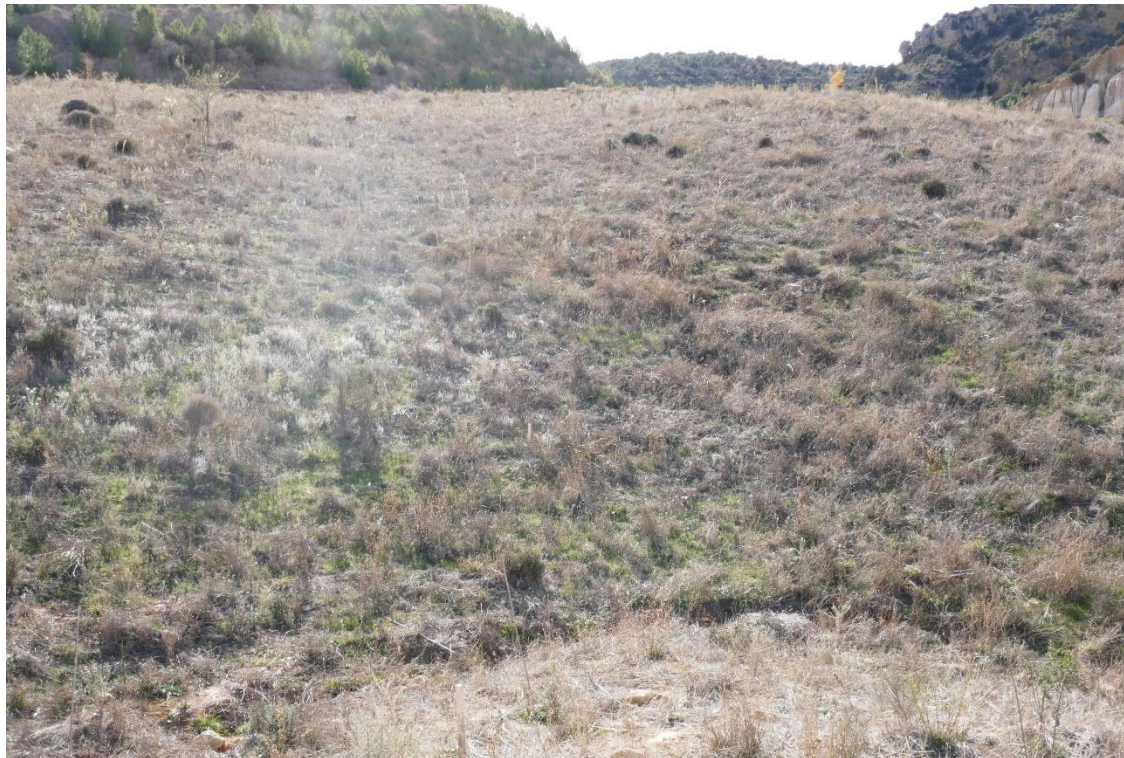
Figure 3. Detail of Western GeoFluv “Conventional GeoFluv with tree holes”. This is the main constructed slope with concave and convex forms. Rills formed in 2019 (photograph above) are not visible in the photograph below (December 2023), covered by vegetation and no longer functional.

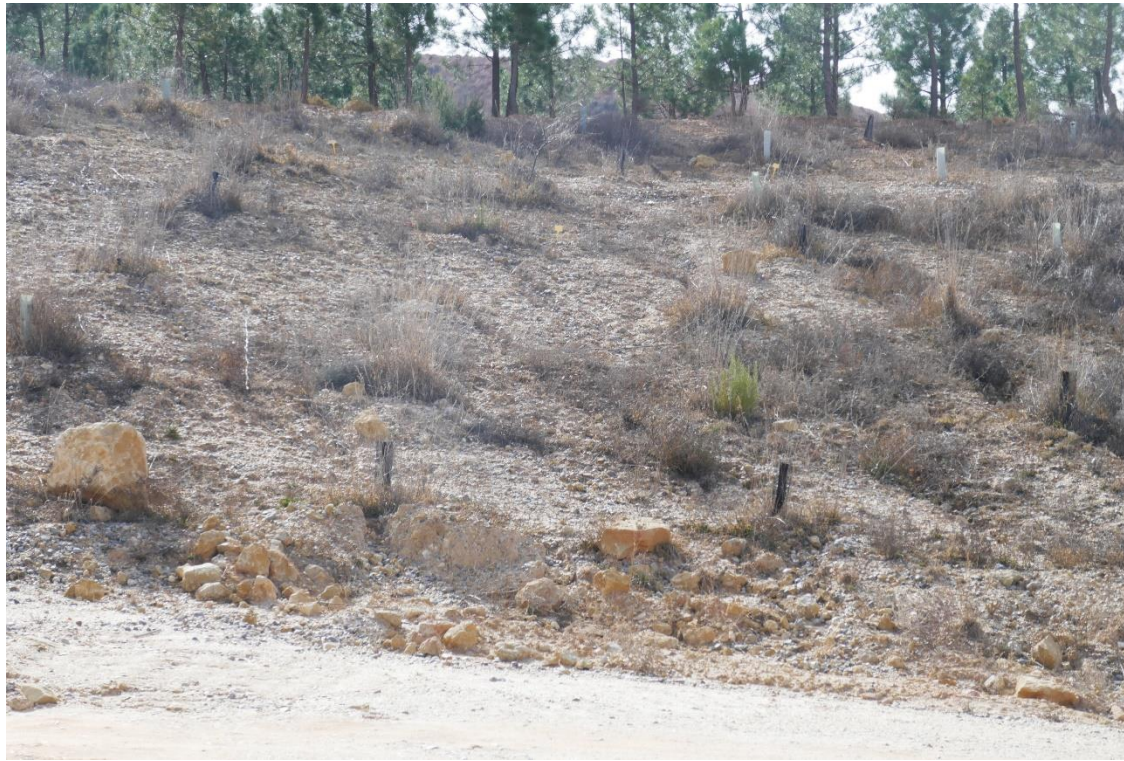
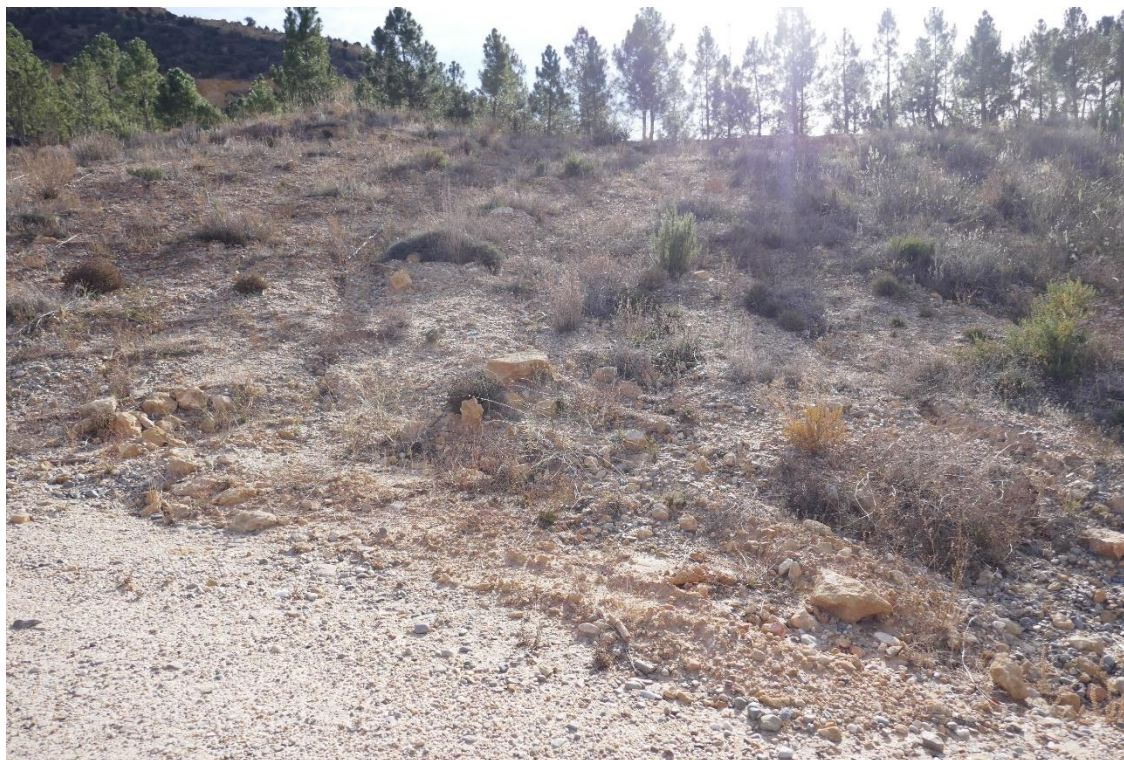
- In Western GeoFluv, the restored zone with overburden substrate evolved from 0.24 to 0.32 m/m<sup>2</sup> in rill density between 2020 and 2021. These were densities well below the 0.60-0.70 m/m<sup>2</sup> that are considered the threshold above which erosion prevents vegetation development in restored mining areas very similar to Fortuna quarry (Moreno de las Heras *et al*, 2009; 2011). Observations made in December 2023 indicate a stabilisation of the erosive forms. The poor development of vegetation is due to the poor quality of the soil. See figure 4.

Figure 4. Western GeoFluv, the restored zone with overburden substrate. There is no difference in the number and size of the rills between the top photograph (February 2022) and the bottom photograph (December 2023). Rills density in 2022 was about 0.32 m/m<sup>2</sup>, below the 0.60-0.70 m/m<sup>2</sup> that is considered the threshold above which erosion prevents vegetation development in restored mining areas very similar to Fortuna quarry (Moreno de las Heras *et al*, 2009; 2011). Observations made in December 2023 indicate a stabilisation of the erosive forms. The poor development of vegetation is due to the poor quality of the soil.

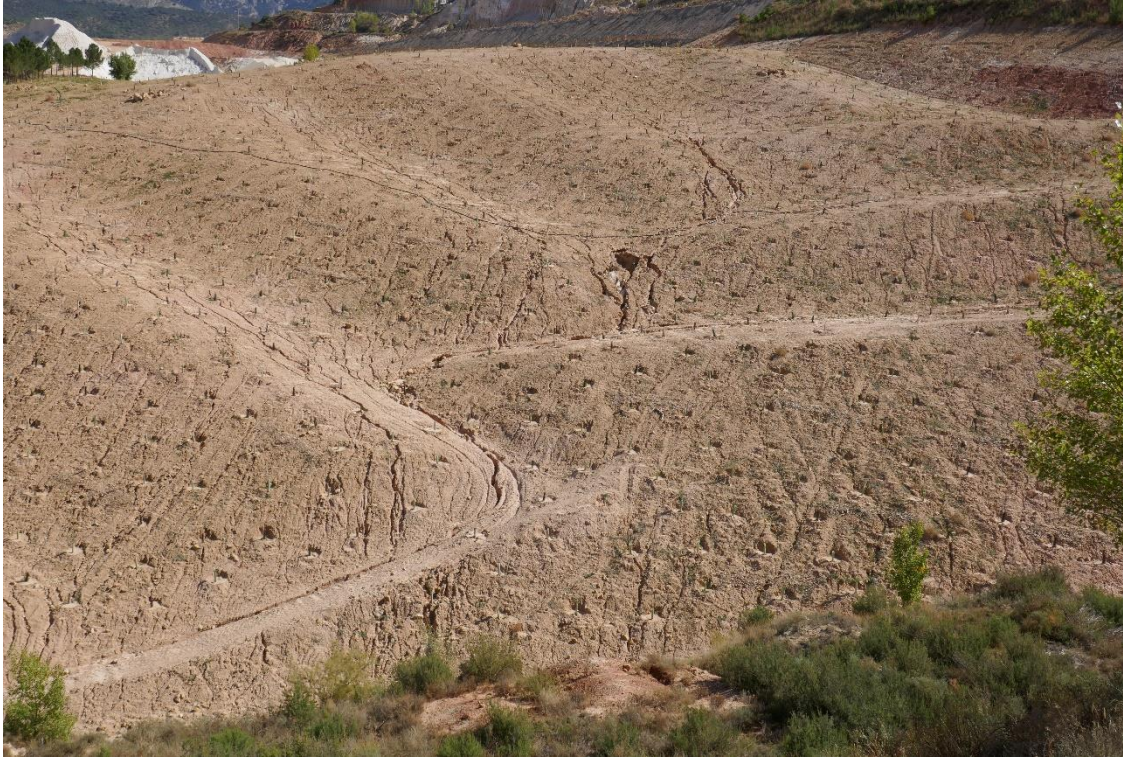
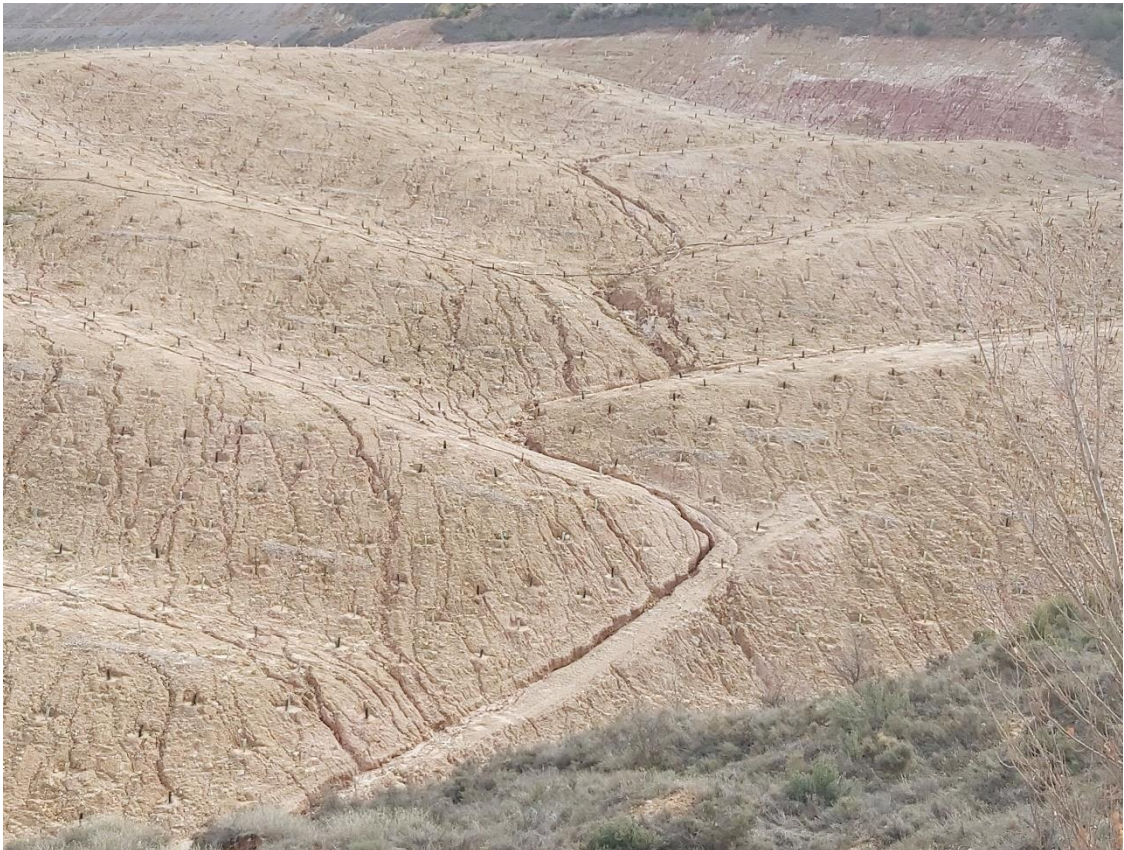
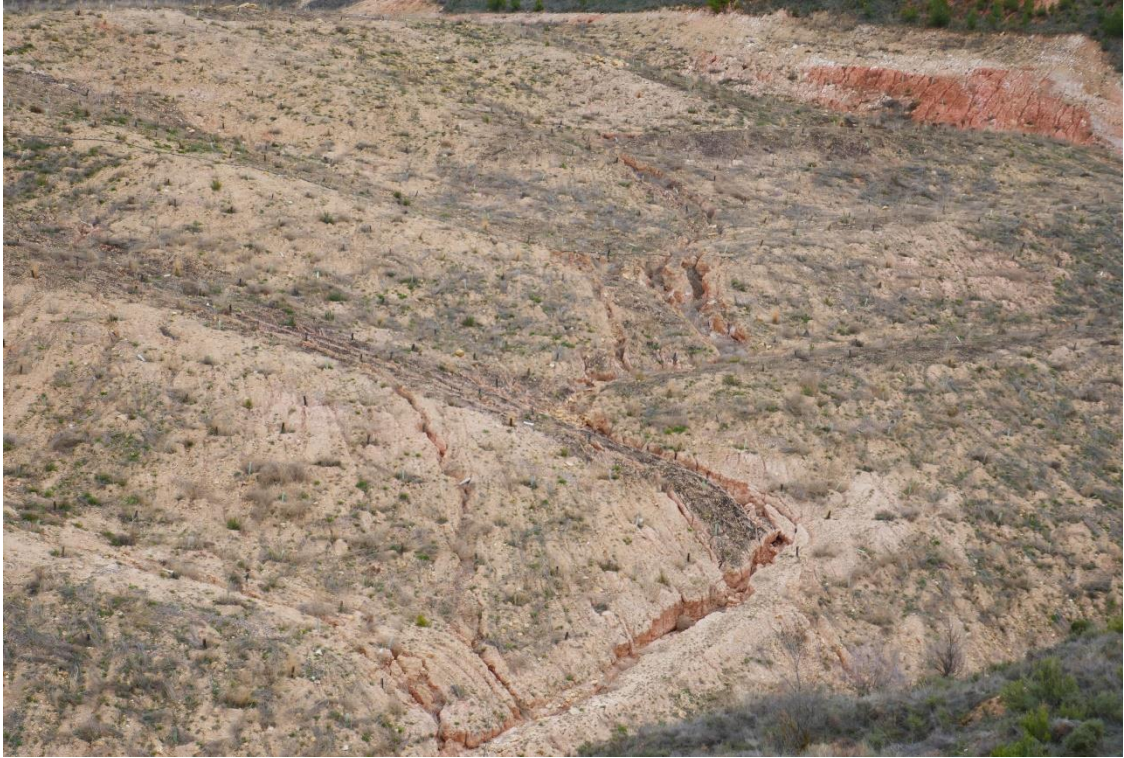
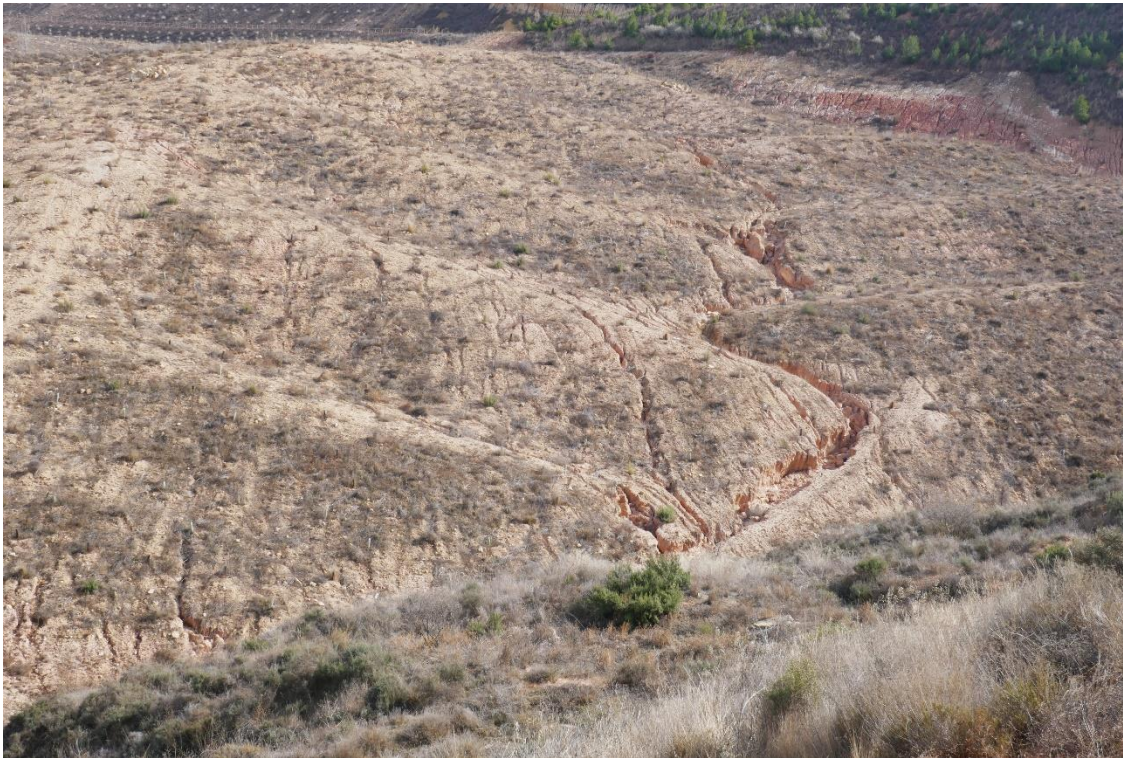
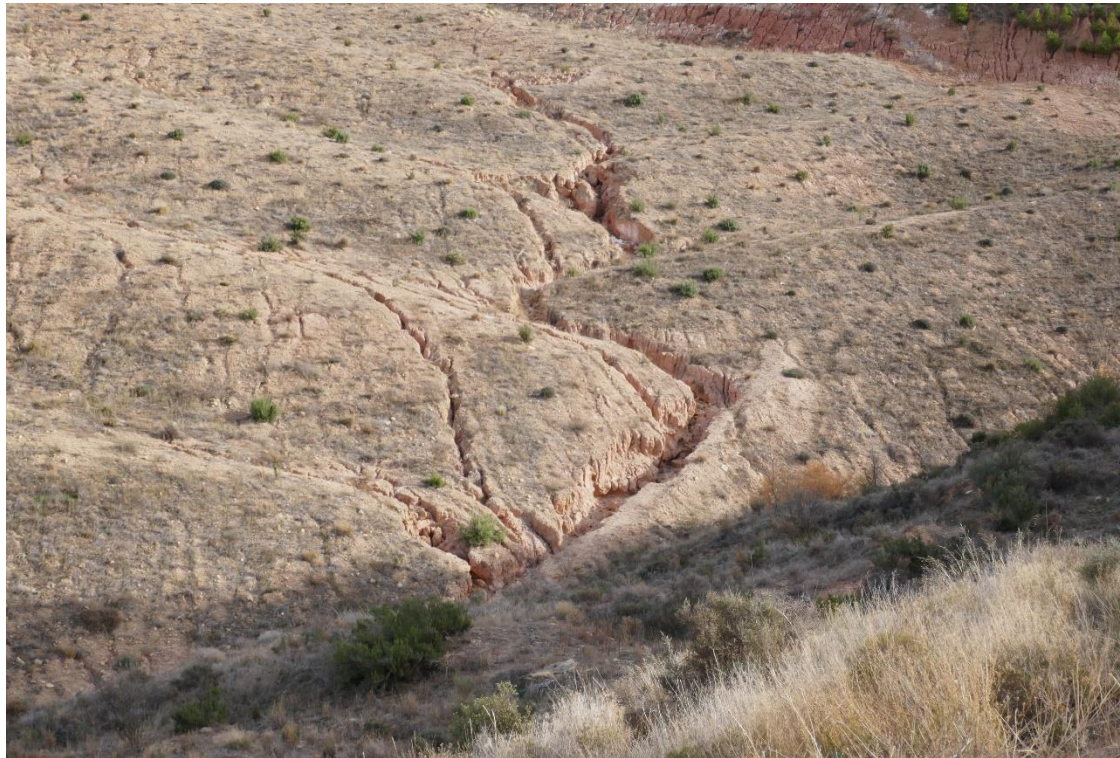
The most critical area from an erosion point of view is the "Abrupt Geomorphological Restoration area" where, on the one hand, the upstream erosion in the main channel of "herringbone" is really important, affecting 77.4% of the length of the channel in 2021. And on the other hand, rill network density is very high, closed to the maximum tolerable rates for plant community can develop (0.60-0.70 m/m<sup>2</sup>). This is why this area needs specific monitoring.

Figure 5 shows the evolution of the erosive forms over the years with images from 09.10.2019; 07.02.2020; 17.03.2021; 11.02.22 and 06.12.23. After the formation of the first drainage network and rills in 2019, a significant growth of the main channel and rills is observed in 2020 (tropical storm "Gloria" occurred in 19-21.01.2020). Erosion actively progressed in 2021 (storm "Filomena" occurred in 05.01.2021). In 2022, no major changes are observed. However, in the last year (2023) there is a widening of the main channel by side walls falling. No conclusions can be drawn on the rills, which will be measured quantitatively in 2024.

Figure 5. Evolution of the erosive forms in abrupt GeoFluv ("herringbone"). The images from top to bottom correspond to 09.10.2019; 07.02.2020; 17.03.2021; 11.02.22 and 06.12.23. The explanation of the erosive evolution can be found in the text.
