C1: Topography and hydrology monitoring

LIFE16 ENV/ES/000159

Author: José Manuel Nicolau Ibarra. Universidad de Zaragoza

2.1. Qualitative (photographic) rills survey

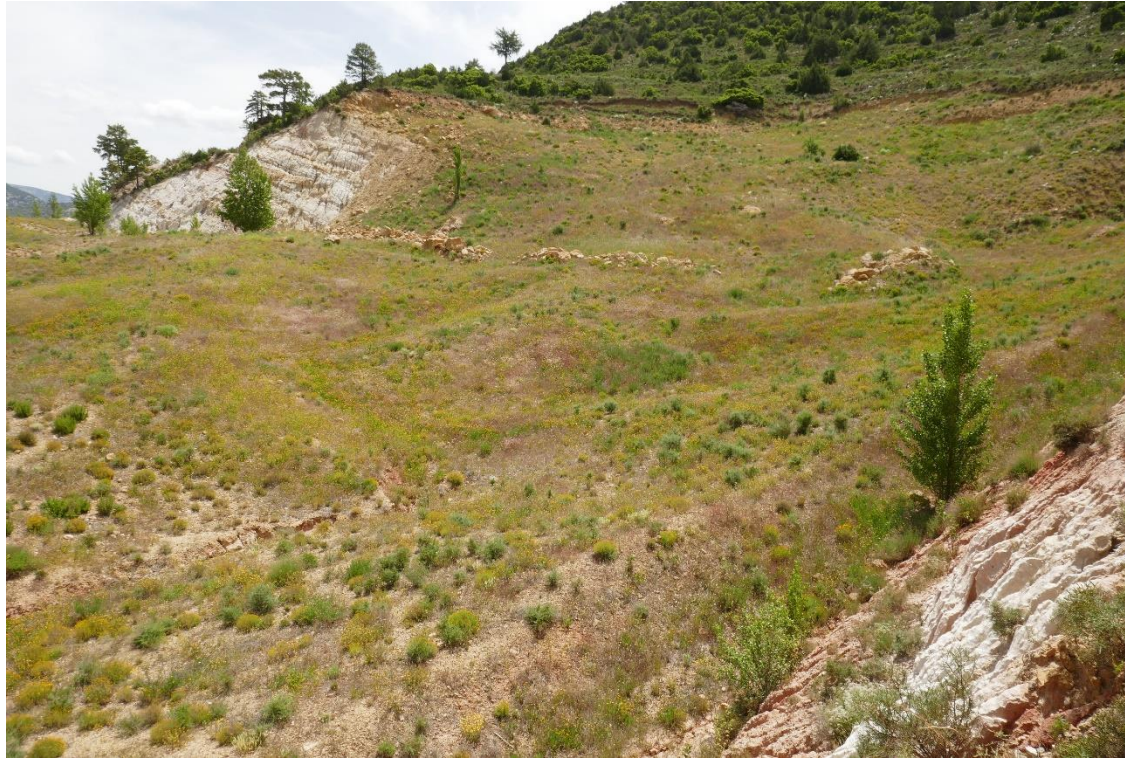
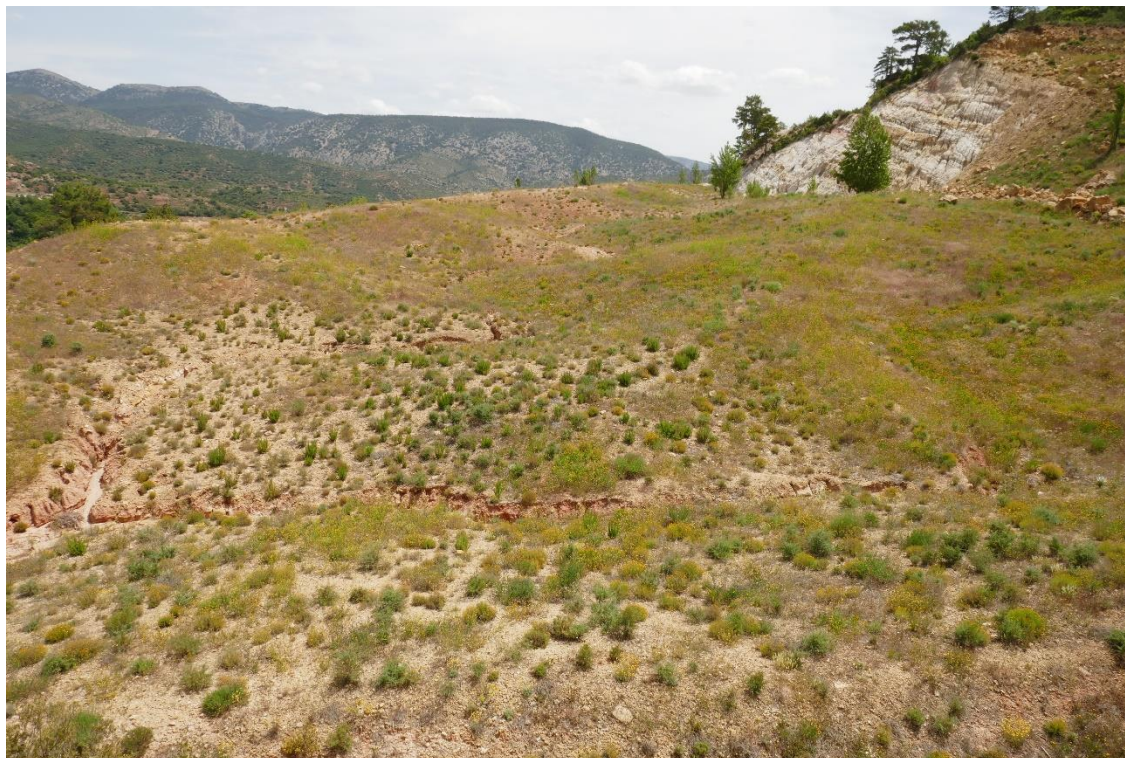
- Eastern GeoFluv (=Conventional GeoFluv without tree holes): no rill networks had been developed in 2021 and 2023. No rills have been found in 2025 either, as shown in the figure 1.
- Western GeoFluv, "Conventional GeoFluv with tree holes": Rill network was underdeveloped in 2021 (rill density: 0.16 m/m²). Photographs and field observations indicate that the rills have become non-functional in some areas as vegetation has developed. No new rills have been developed in 2023 and 2025. See figures 2 and 3.
- In Western GeoFluv, the restored zone with overburden substrate evolved from 0.24 to 0.32 m/m² in rill density between 2020 and 2021. These were densities well below the 0.60-0.70 m/m² that are considered the threshold above which erosion prevents vegetation development in restored mining areas very similar to Fortuna quarry

Figure 1. Panoramic view of Eastern GeoFluv (=Conventional GeoFluv without tree holes) in 05.06.2025. No rill system has developed and vegetation is not limited by erosion. The photo above is of the western side and the photo below is of the eastern side.

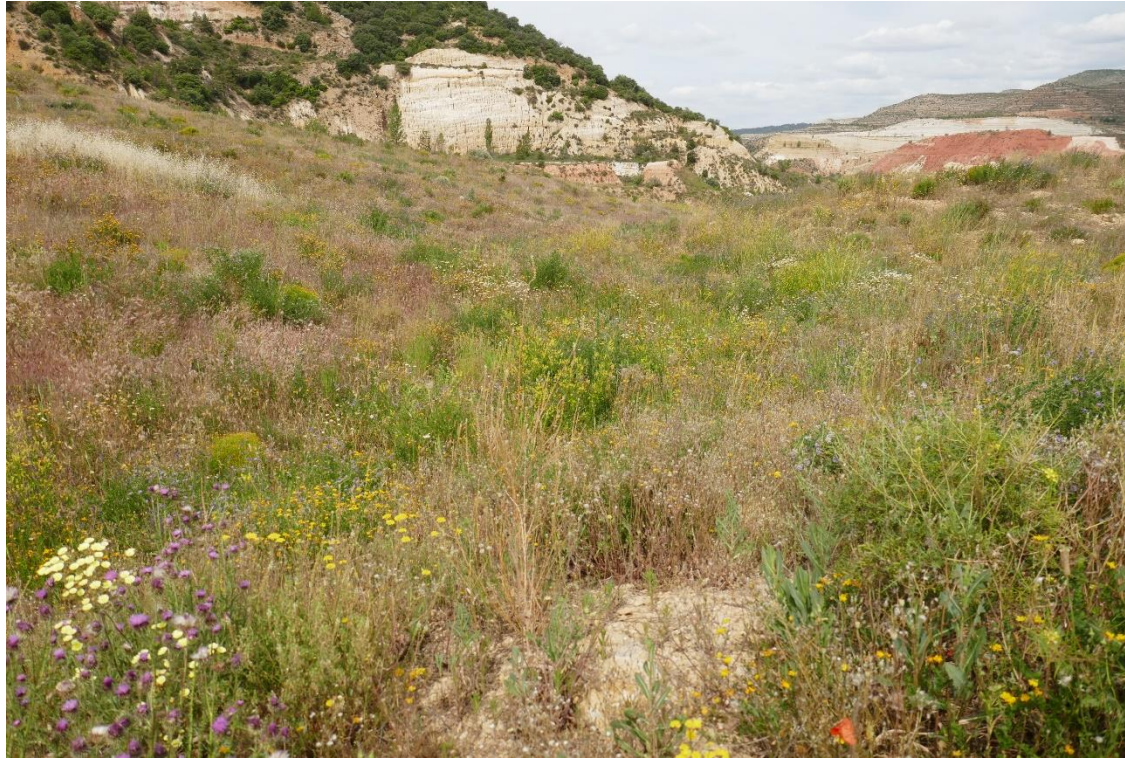
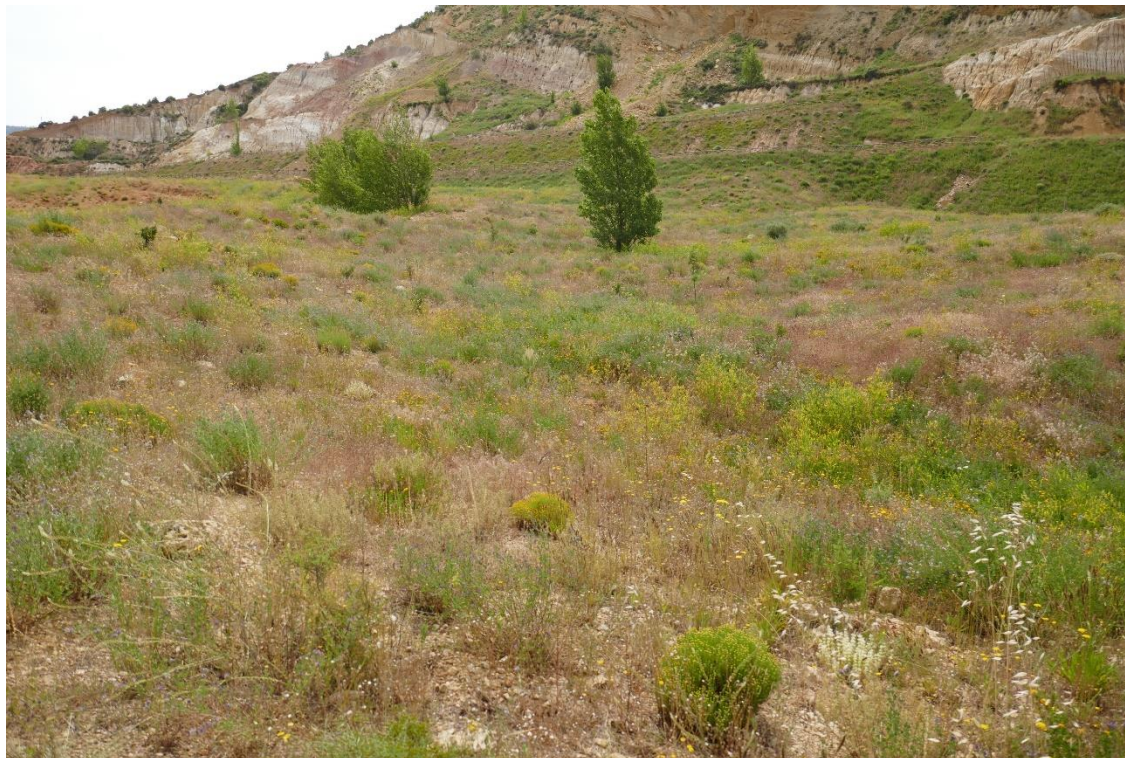
Figure 2. Panoramic view of Western GeoFluv “Conventional GeoFluv with tree holes” in 05.06.2025. Photographs and field observations indicate that the rills have become non-functional in some areas as vegetation has developed. No new rills have been developed. The photograph above corresponds to the lower part of the basin and the one below to the upper part.

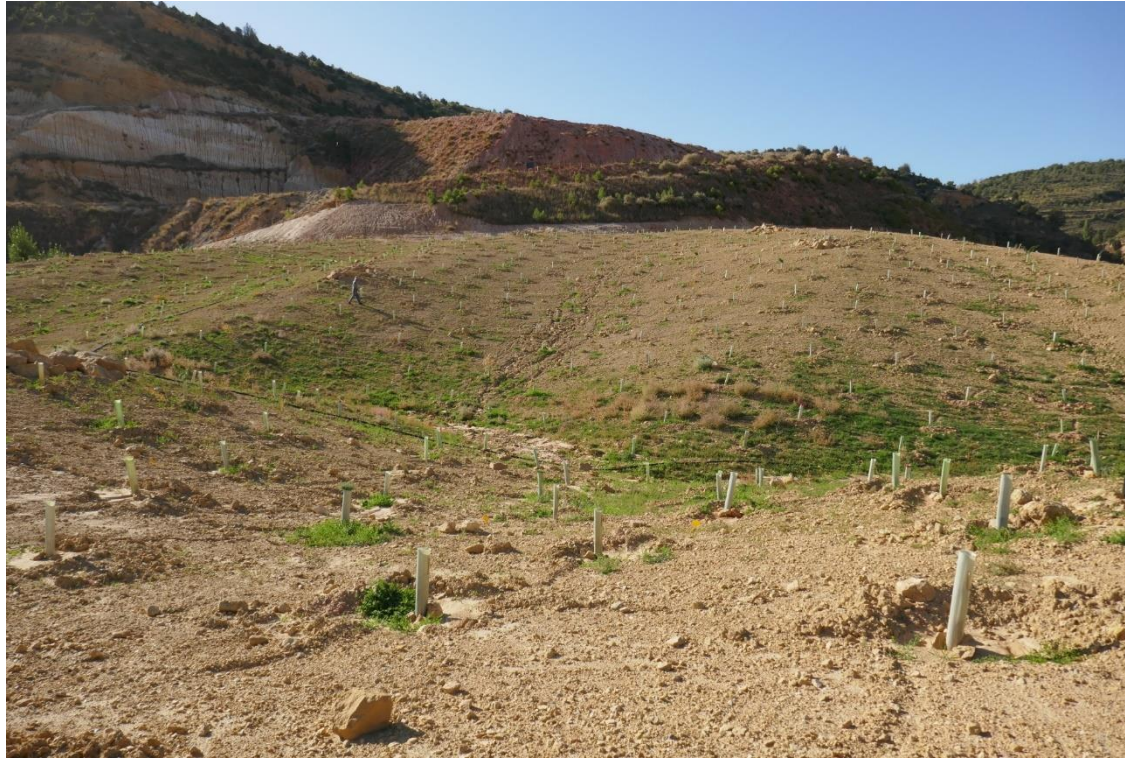
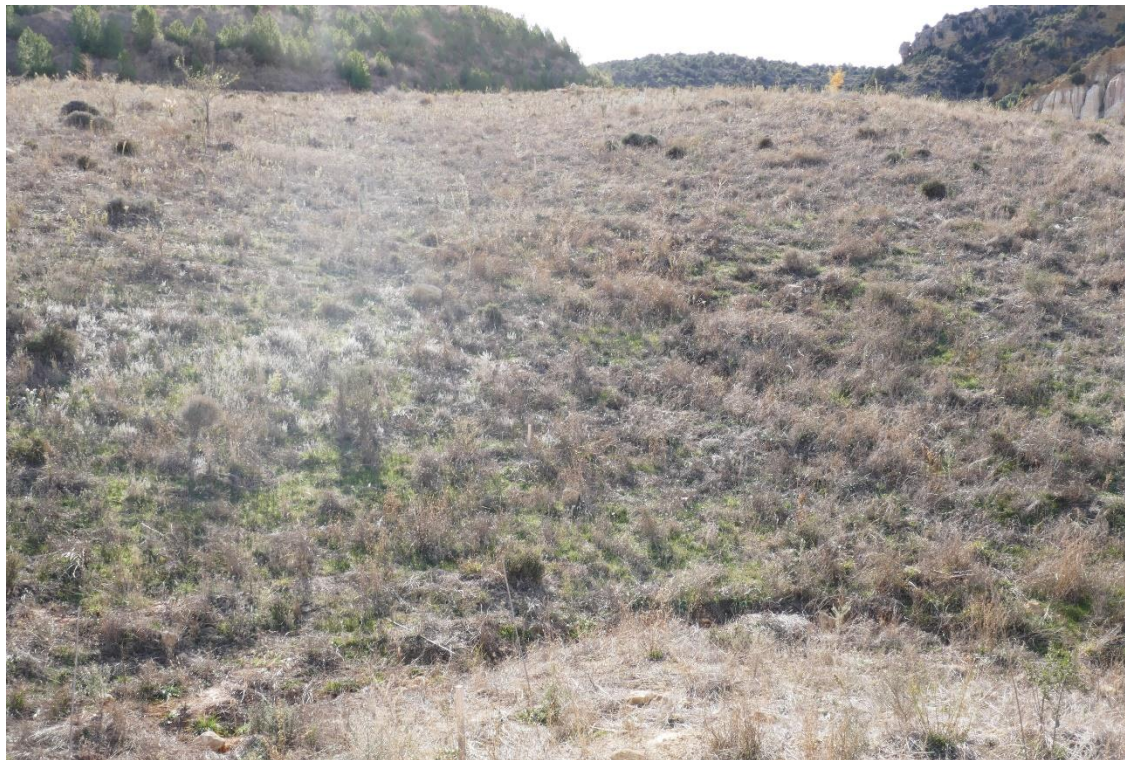
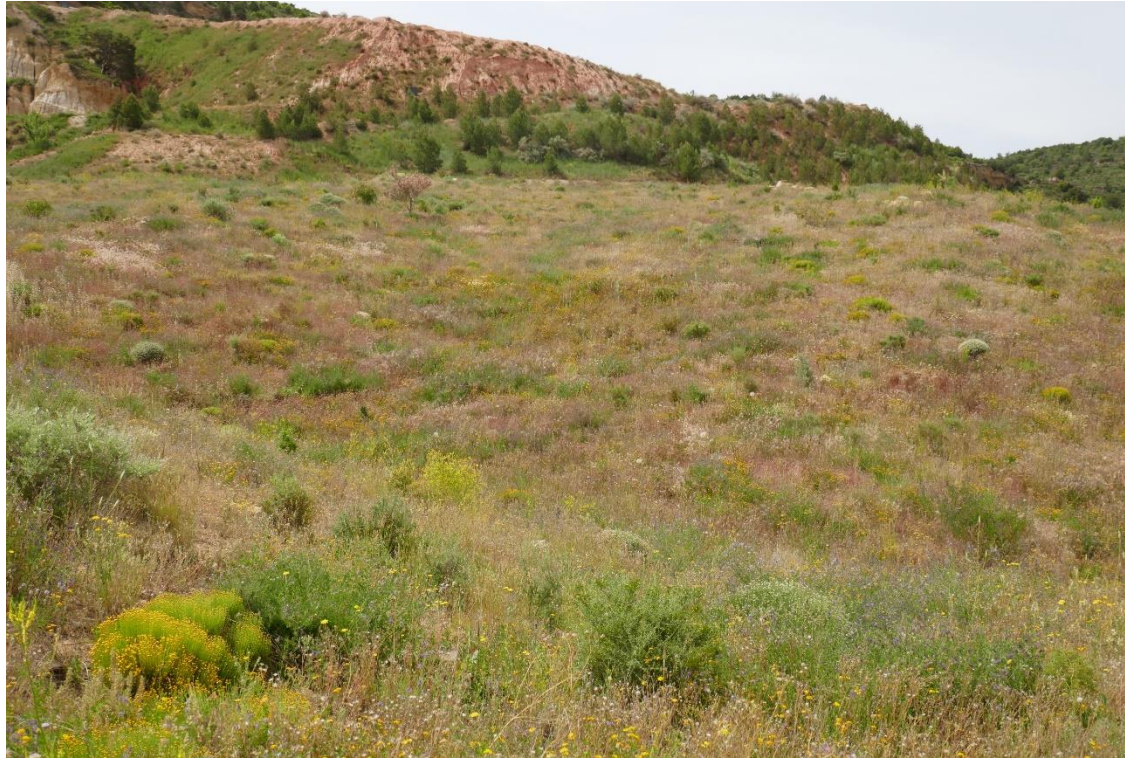
Figure 3. Detail of Western GeoFluv “Conventional GeoFluv with tree holes”. This is the main constructed slope with concave and convex forms. Rills formed in 2019 (photograph above) are not visible in the photograph intermediate (December 2023). Photograph below (June 2025) shows vegetation covering 100% of soil surface.

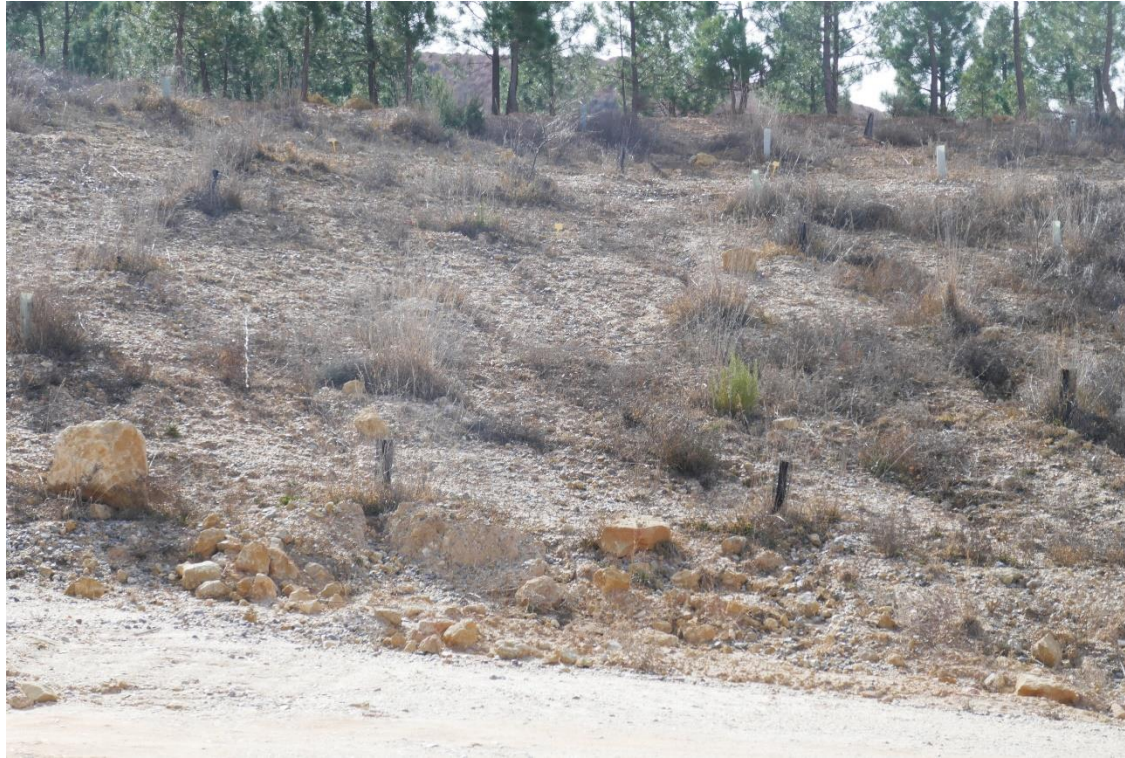
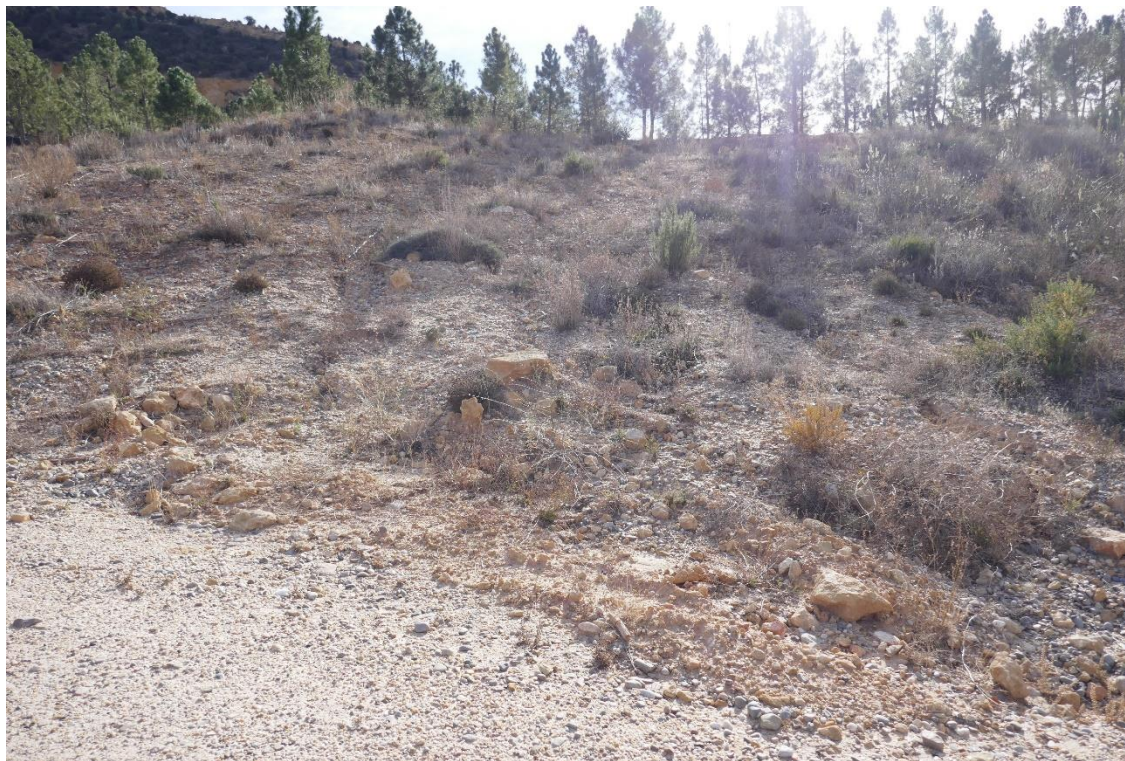
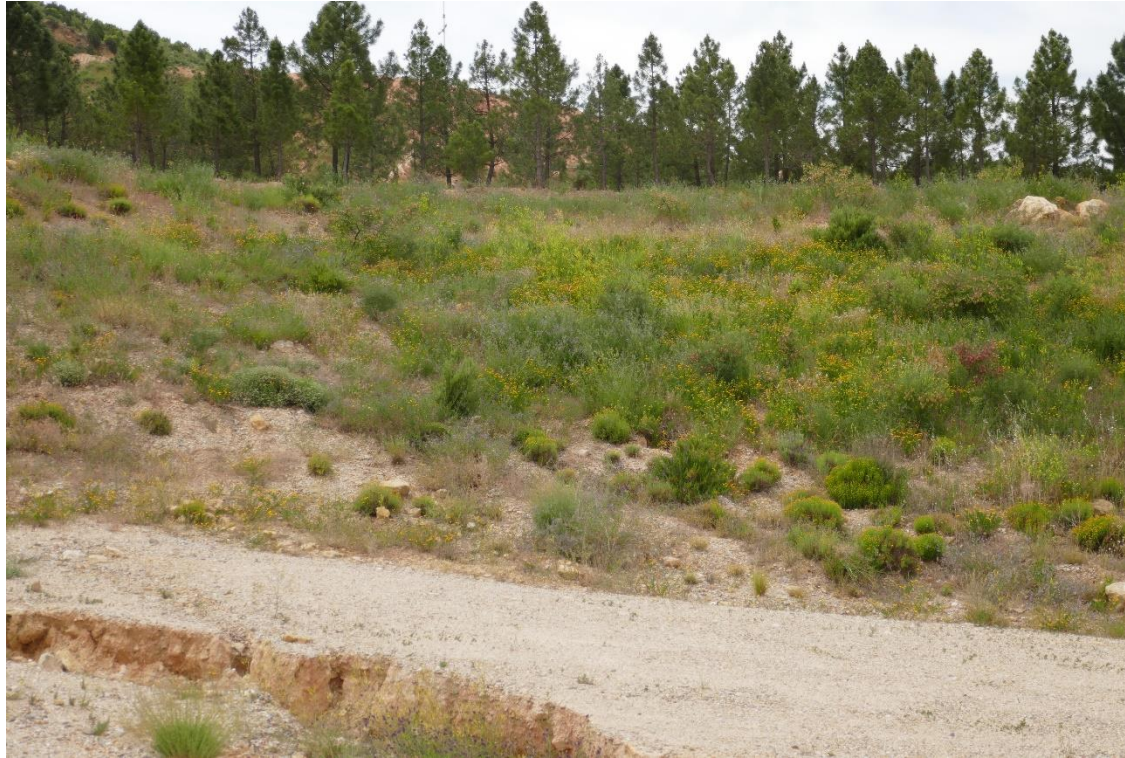
(Moreno de las Heras et al, 2009; 2011). Observations made in December 2023 and 2025 indicate a stabilisation of the erosive forms. The development of vegetation was poor in 2023 due to the poor quality of the soil. However, in 2025 plant cover is much higher because of the good environmental conditions in 2025's spring. See figure 4.

Figure 4. Western GeoFluv, the restored zone with overburden substrate. There is no difference in the number and size of the rills between the top photograph (February 2022) and the intermediate photograph (December 2023), which indicates a stabilisation of the erosive forms. Rills density in 2022 was about 0.32 m/m^2 , below the $0.60\text{-}0.70 \text{ m/m}^2$ that is considered the threshold above which erosion prevents vegetation development in restored mining areas very similar to Fortuna quarry (Moreno de las Heras et al., 2009; 2011). Observations made in June 2025 (photograph below) shows higher plant cover due to the mild spring time.

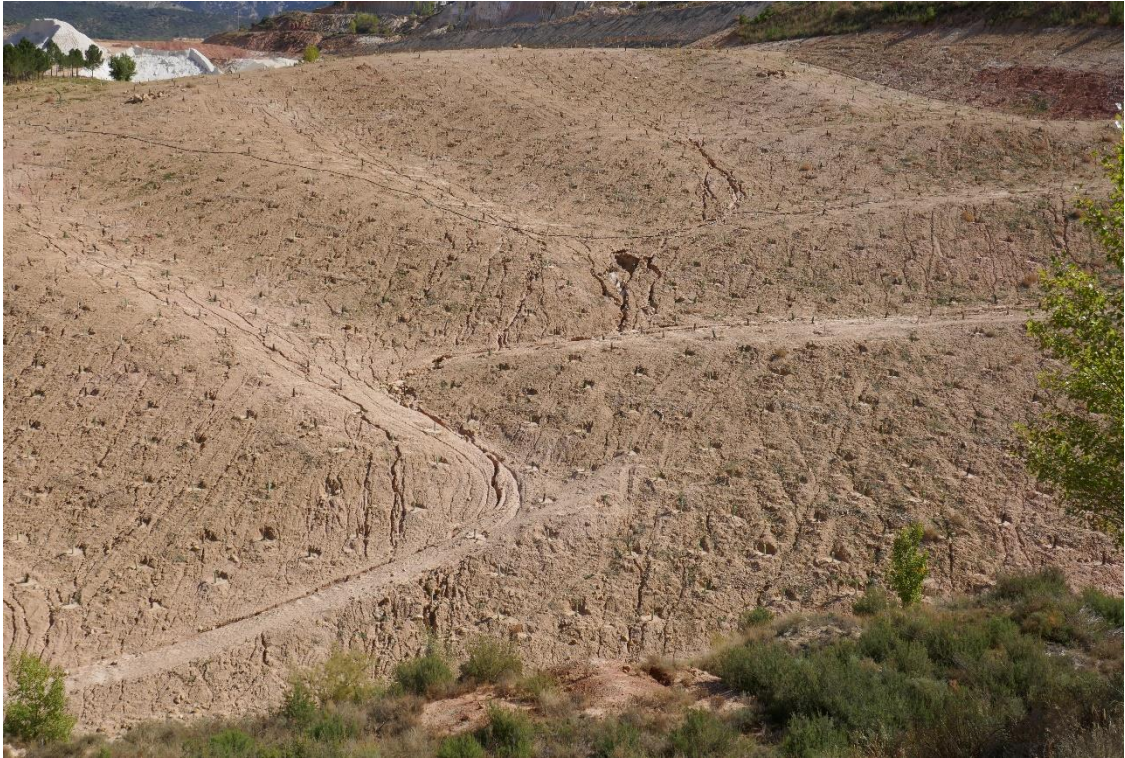
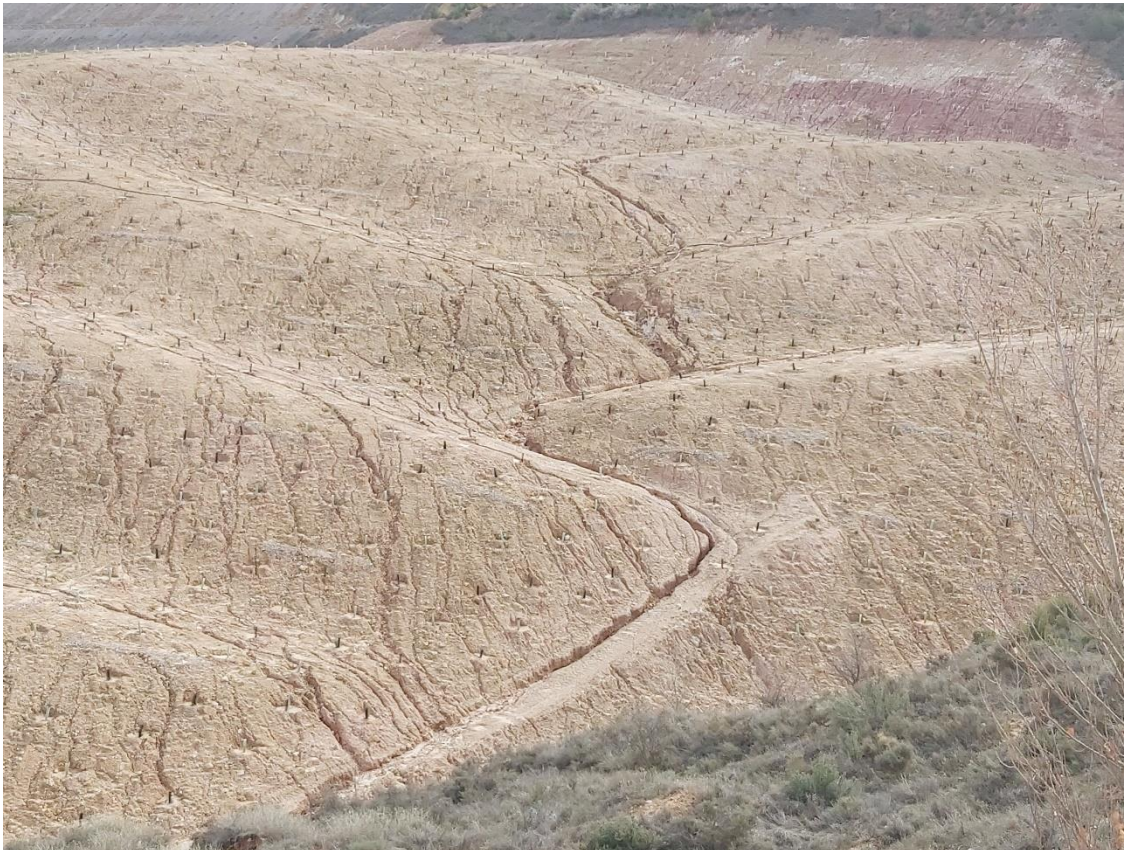
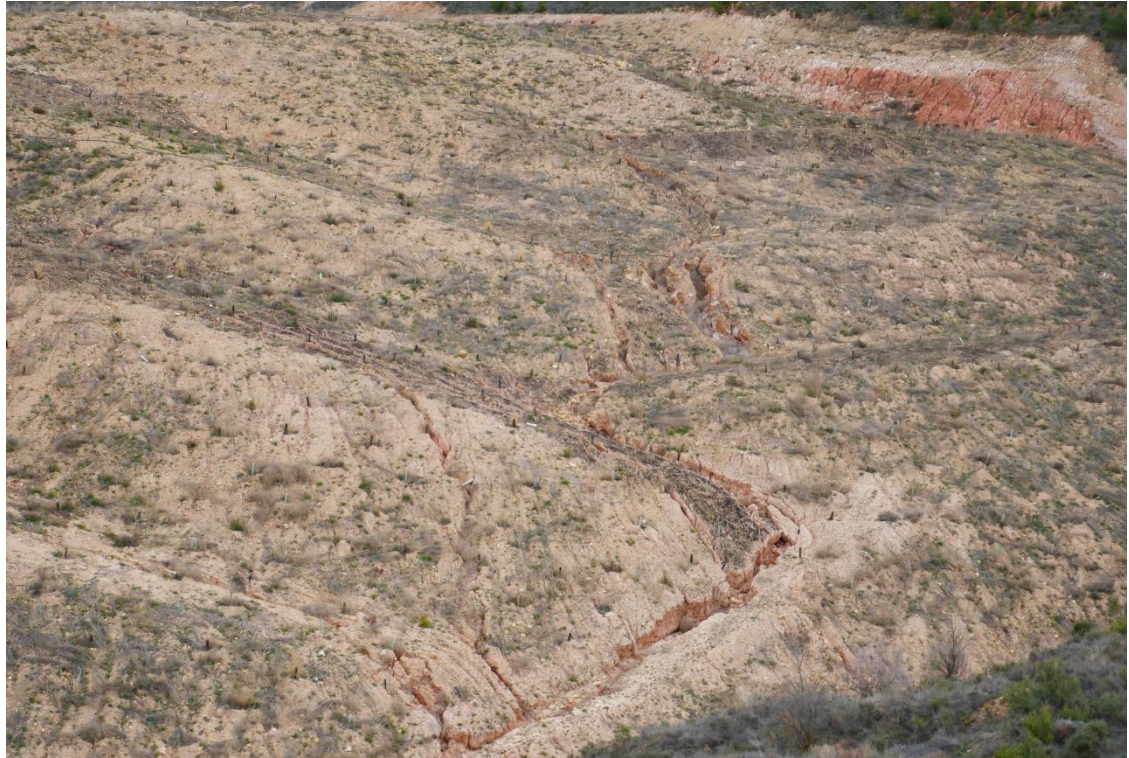
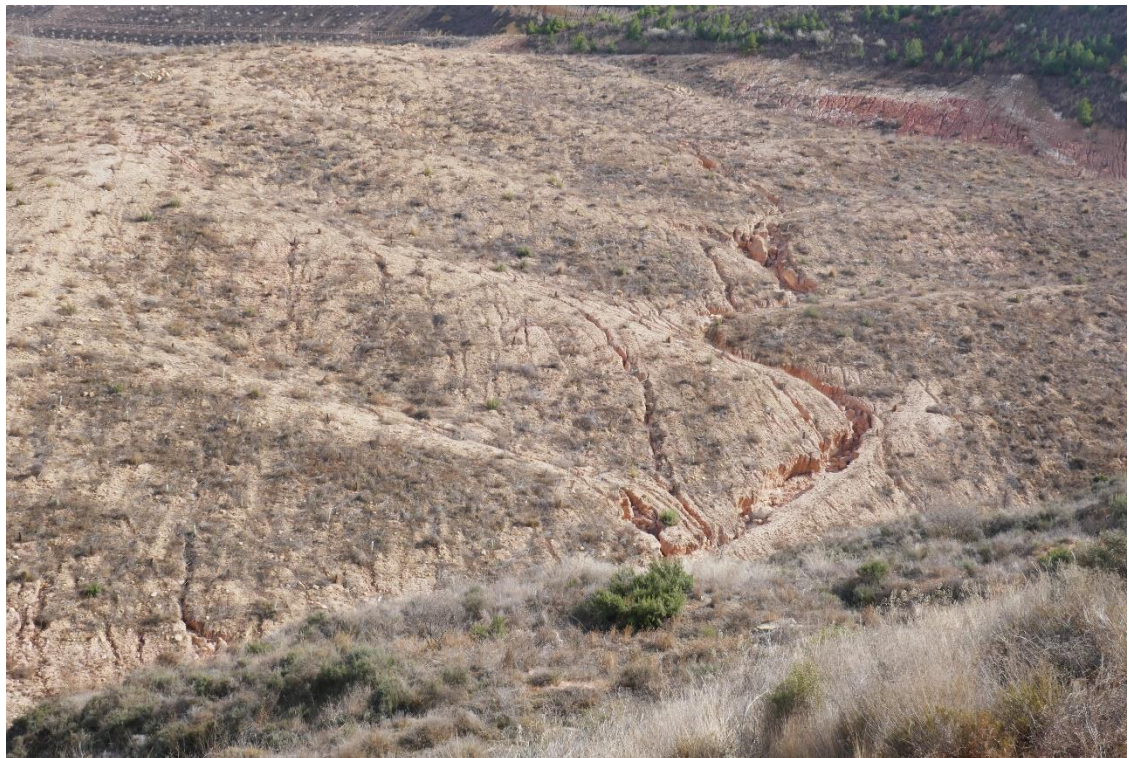
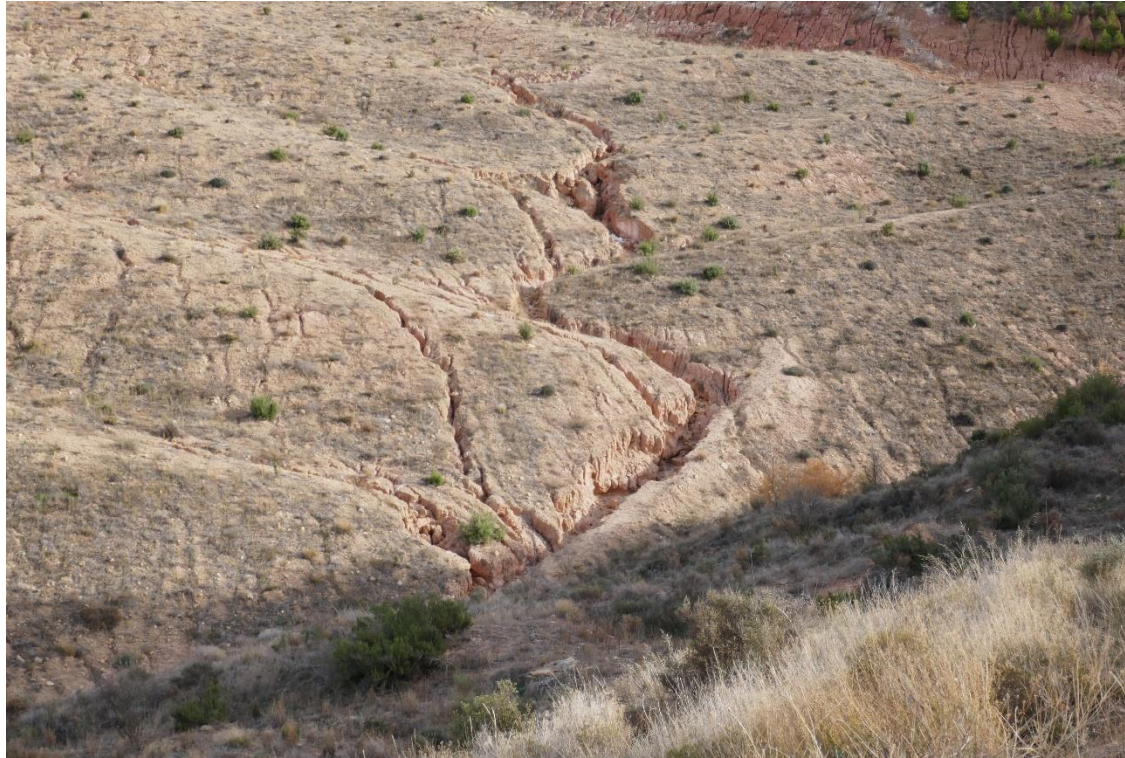
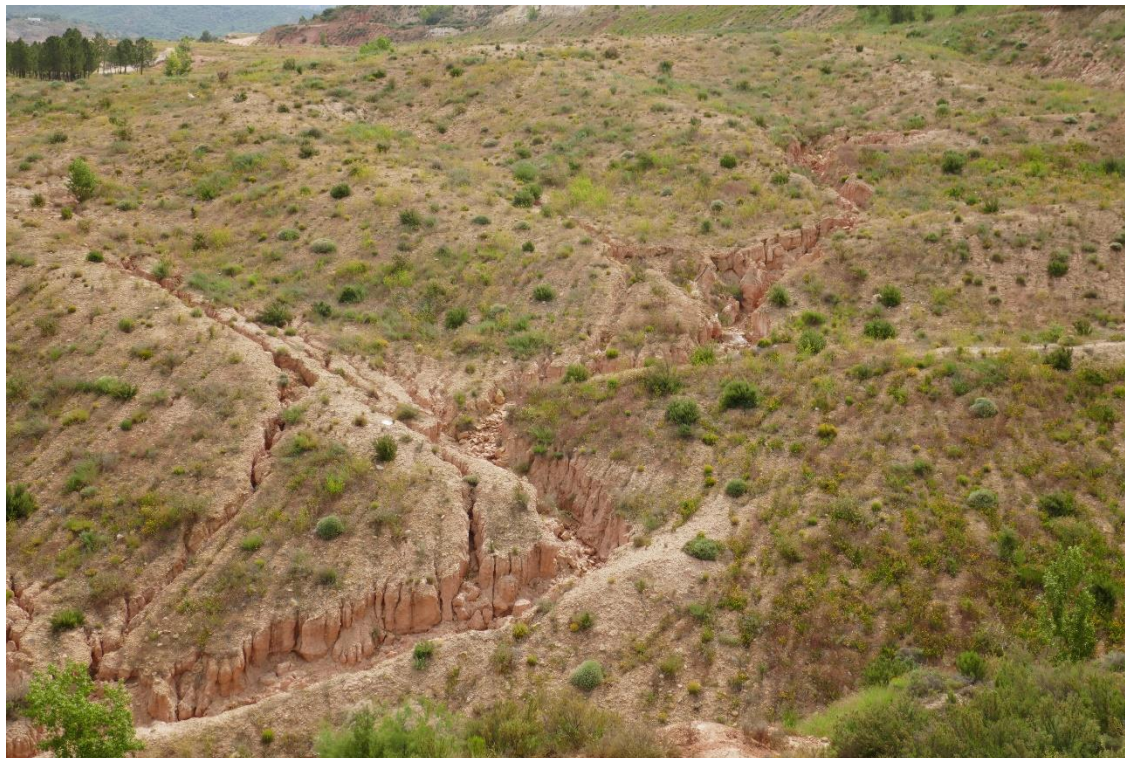
The most critical area from an erosion point of view is the "Abrupt Geomorphological Restoration area" where, on the one hand, the upstream erosion in the main channel of "herringbone" is really important, affecting 77.4% of the length of the channel in 2021. And on the other hand, rill network density is very high, closed to the maximum tolerable rates for plant community can develop (0.60-0.70 m/m²). This is why this area needs specific monitoring.

Figure 5 shows the evolution of the erosive forms over the years with images from 09.10.2019; 07.02.2020; 17.03.2021; 11.02.22, 06.12.23 and 05.06.2025. After the formation of the first drainage network and rills in 2019, a significant growth of the main channel and rills is observed in 2020 (tropical storm "Gloria" occurred in 19-21.01.2020). Erosion actively progressed in 2021 (storm "Filomena" occurred in 05.01.2021). In 2022, no major changes were observed. In 2023 and 2025 there was a widening of the main channel and its tributaries by side walls falling and river bed wedging. Vegetation continues developing in this erosive environment: both, herbaceous and shrub cover have increased significantly in 2025.

Figure 5. Evolution of the erosive forms in abrupt Geomorphic ("herringbone"). The images from top to bottom correspond to 09.10.2019; 07.02.2020; 17.03.2021; 11.02.22, 06.12.23 and 05.06.25. The explanation of the erosive evolution can be found in the text.

The evolution of erosional forms in the abrupt ("herringbone") is still active. In 2025 the main channel and tributaries have continued the widening and deepening process. However, vegetation development (both, herbaceous and shrub species) on the slopes has been very significant in 2025, which indicates that erosion is not impeding vegetation establishment.
