C. Monitoring of the Impact of the Project actions. Action C 1.1

Monitoring of topographic evolution and erosion rate

LIFE16 ENV/ES/000159

February 2022

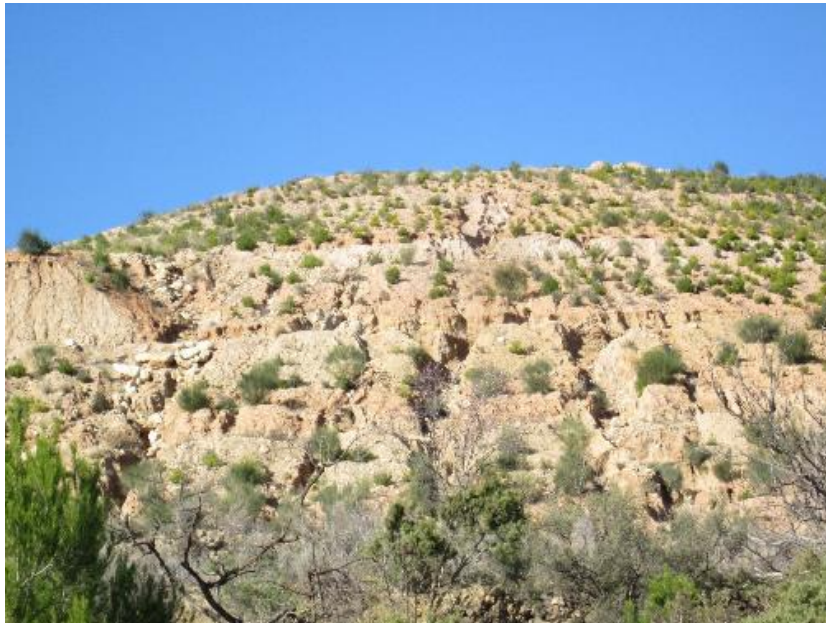
Figure 1. Rill and gully formation on a steep long restored outslope and berms. Observe the propagation of gullies to the higher parts of the slope. It is also possible to see the lack of soil and the poor performance of the pine trees and some shrubs plantation.

Water erosion in mining restorations is mainly caused by the construction of inadequate geomorphologies (topography and substrate). The “dump heap” type topography, also known as the “slope-berm-ditch model” is very widespread (Nicolau, 2003). These are reliefs with more or less steep rectilinear slopes, stepped in berms (terraces) and with a drainage network made up of ditches to evacuate the water generated on the slopes and collected in the berms. This artificial drainage system has been shown to be non-functional in evacuating runoff from the most intense rainfall events. The water is often retained in the berms, causing them to break and the formation of gullies on the slopes. On the other hand, the slopes -without a drainage network- can experience processes of sheet erosion and rills network development, even with some gullies. These are favored by a very frequent circumstance in these mining topographies: the entry of exogenous runoff through the head of the slopes, which advises maximum control over them in restoration projects (Hancock et al., 2003). The negative effects of the topography are accentuated when the restored substrates have a low rainwater infiltration capacity and/or have a high erodibility. Figure 1 shows an example of this type of restoration.

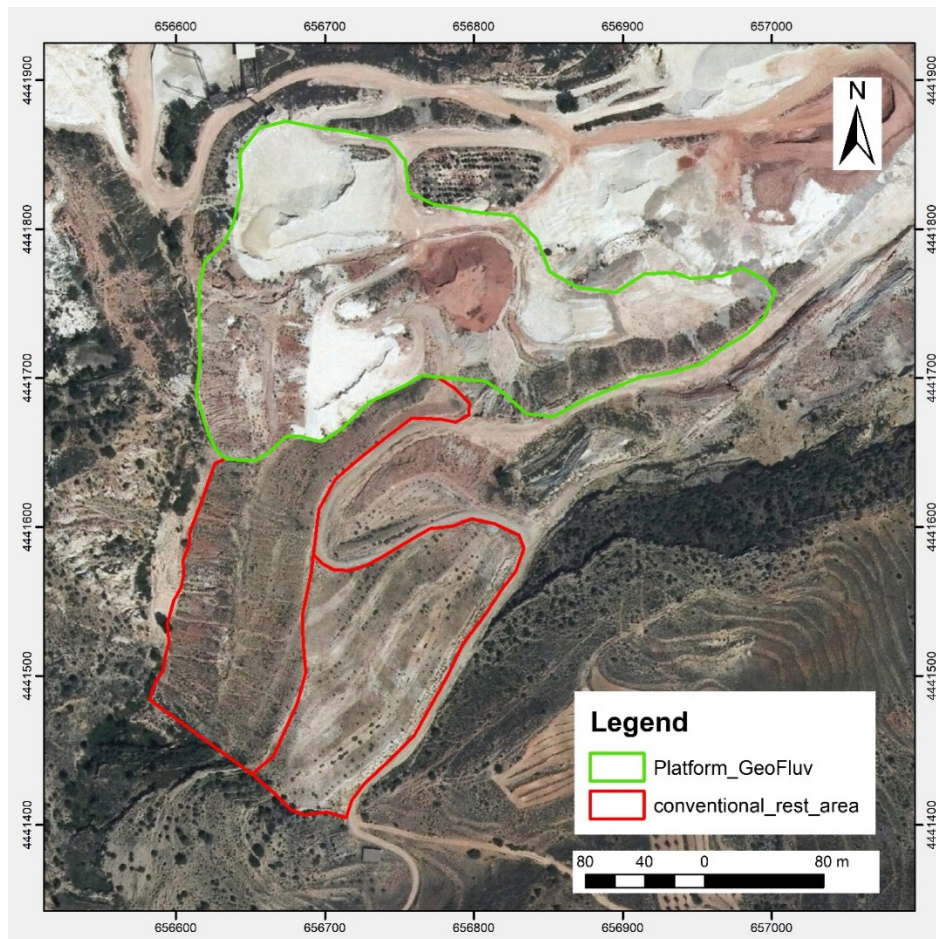
Figure 2. Fragment of the PNOA aerial orthophoto showing (approximately) the platform area that will be restored within the TECMINE project (green line) and the conventionally restored terraces where erosion has been measured (red line) (Coordinate System UTM-30N, Datum ETRS 1989).

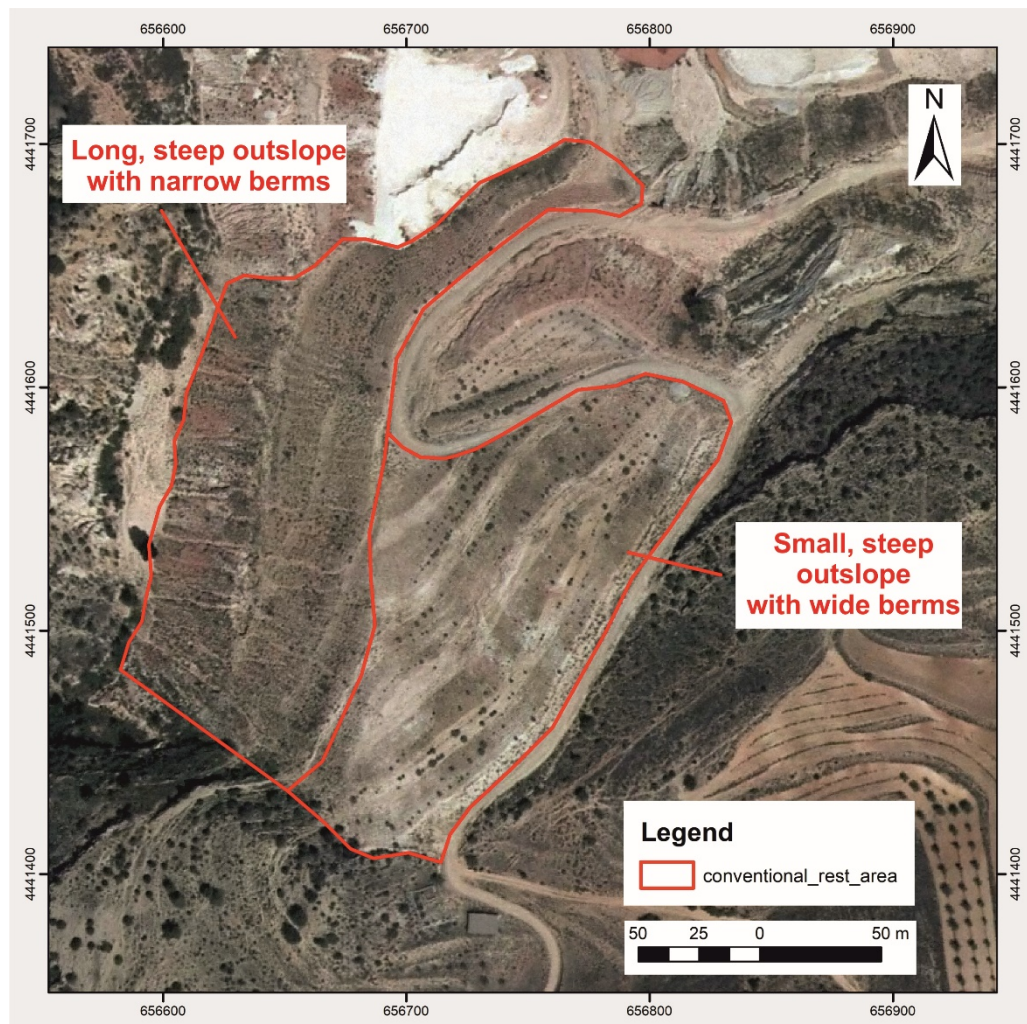
Figure 3. Fragment of the PNOA aerial orthophoto showing the two types of conventionally restored terraces, where erosion has been measured (Coordinate System UTM-30N, Datum ETRS 1989)

First of all, the surface occupied by the two types of spoil heap was delimited (red line in Figure 3). They are characterized by:

- Type 1: long, steep outslope with narrow berms
- Type 2: small, steep outslope with wide berms

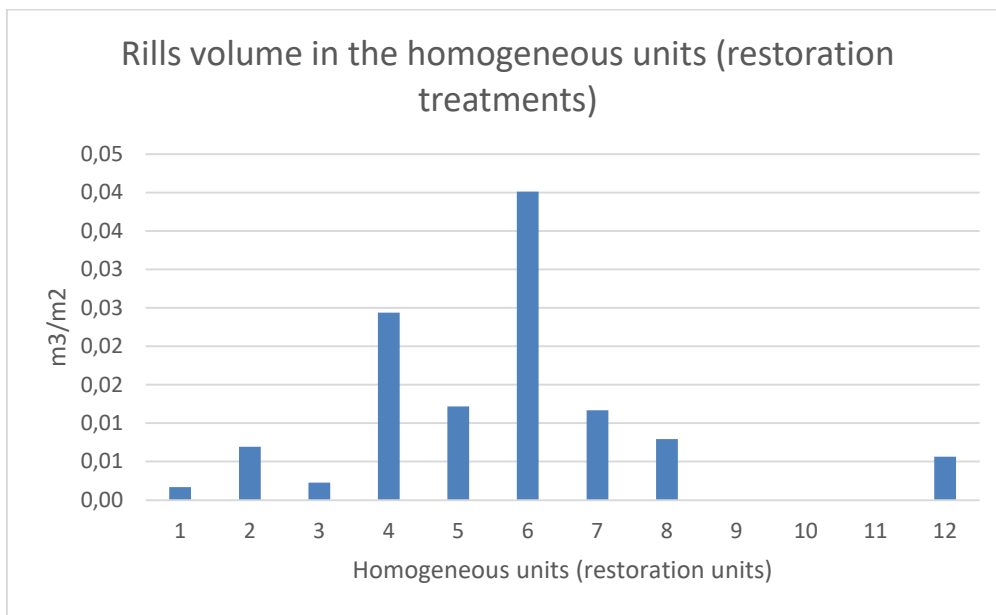
Figure 19. Rills volume per surface (m³/m²) in the homogeneous units, 2 years after Fortuna quarry restoration. Homogeneous units are as follows:

- GeoFluv - overburden substrate - convex (hill) landform (Code 1)
- GeoFluv - overburden substrate - concave (valley) landform (Code 2)
- Canonical GeoFluv - colluvion - convex (hill) (Code 3)
- Abrupt GeoFluv ("Fishbone") - berm and slope in south exposure (Code 4)
- Abrupt GeoFluv ("Fishbone") - berm and shady slope (Code 5)
- Abrupt GeoFluv - concave (valley) landform (Code 6)
- Abrupt GeoFluv - convex (hill) landform (Code 7)
- Canonical GeoFluv – concave (valley) – shady (Code 8)
- Canonical GeoFluv - convex (hill) - shady (Code 9)
- Canonical GeoFluv – concave (valley) – south exposure (Code 10)
- Abrupt GeoFluv no revegetated (Code 11). Not included in the figure.
- Abrupt GeoFluv – flat area (Code 12)

Figures 19 and 20 displays the rill erosion magnitude in the homogeneous units, in terms of rills volume per surface (figure 19) and rills erosion rate (figure 20). The outputs of both graphics are similar. The Abrupt GeoFluv restoration has the highest rill erosion rates. They are especially high in the experimental zone without revegetation (11) and, in a second level, the concavities (6) and sun exposure (4). The areas with Canonical GeoFluv present the lowest values and the areas with overburden, intermediate values.

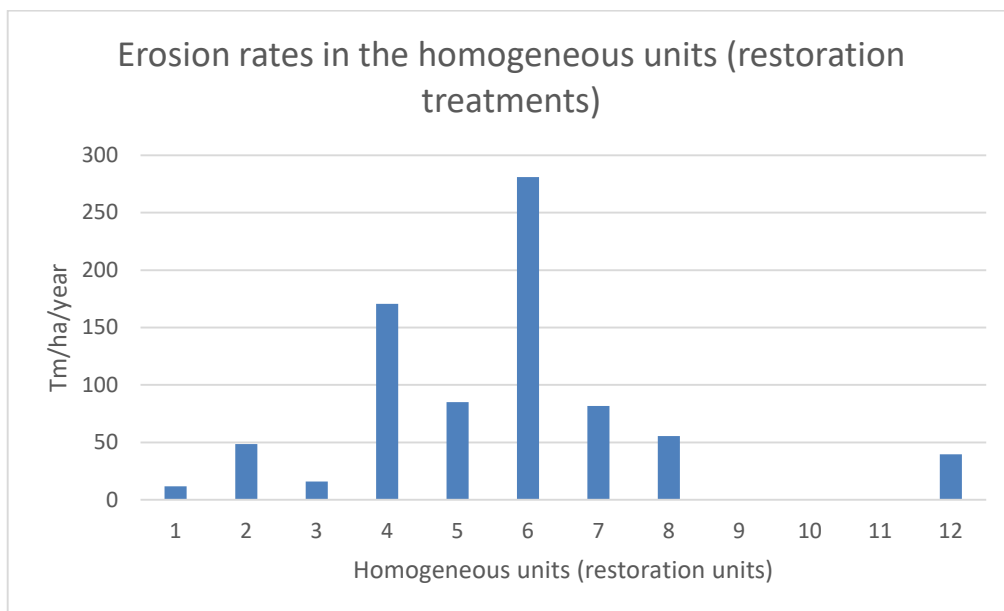
Figure 20. Rills erosion rate in the homogeneous units, 2 years after Fortuna quarry restoration. Homogeneous units are as follows:

- GeoFluv - overburden substrate - convex (hill) landform (Code 1)
- GeoFluv - overburden substrate - concave (valley) landform (Code 2)
- Canonical GeoFluv - colluvion - convex (hill) (Code 3)
- Abrupt GeoFluv (“Fishbone”) - berm and slope in south exposure (Code 4)
- Abrupt GeoFluv (“Fishbone”) - berm and shady slope (Code 5)
- Abrupt GeoFluv - concave (valley) landform (Code 6)
- Abrupt GeoFluv - convex (hill) landform (Code 7)
- Canonical GeoFluv – concave (valley) – shady (Code 8)
- Canonical GeoFluv - convex (hill) - shady (Code 9)
- Canonical GeoFluv – concave (valley) – south exposure (Code 10)
- Abrupt GeoFluv no revegetated (Code 11). Not included in the figure.
- Abrupt GeoFluv – flat area (Code 12)
