Deliverable on establishment success of plantations: Survival and Growth

LIFE16 ENV/ES/000159

TECMINE After-LIFE. Action 1. MONITORING OF PLANT SURVIVAL AND GROWTH

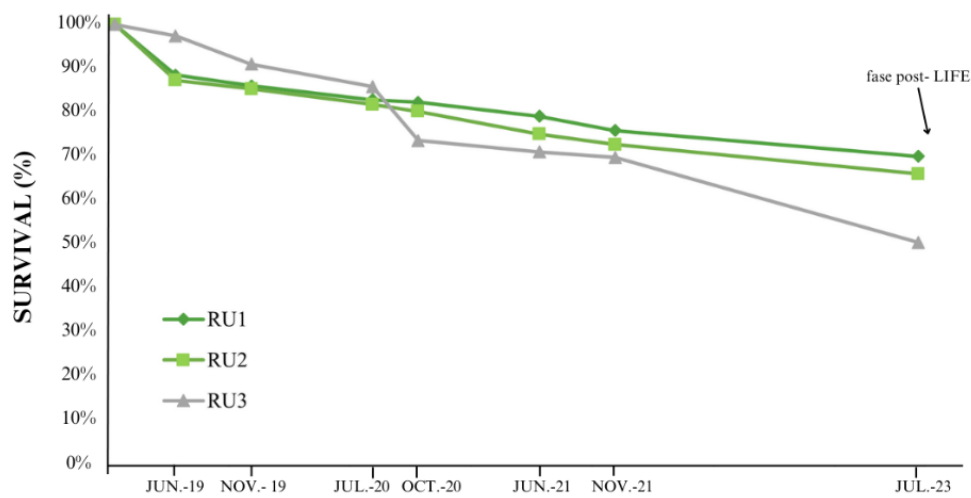
During the After-LIFE monitoring conducted in July-23 (4.5 years after outplanting), average survival rates of the introduced seedlings in the *Geofluv West* restored unit, was 66% (± 0.02 SE). Regarding each restoration unit: RU1, RU2 and RU3 was 70% (± 0.02 SE), 68% (± 0.03 SE) and 51% (± 0.04 SE) respectively. The results showed the lowest survival rates in RU3 (Fig 2). Nevertheless, survival kept still over 50% of the introduced seedlings.

Fig. 2. Survival dynamics across time in the restored area (Geofluv West area) of the TECMINE project for each Restoration Unit: dark green - diamonds = RU1; light green - square = RU2; grey - triangle = RU3.

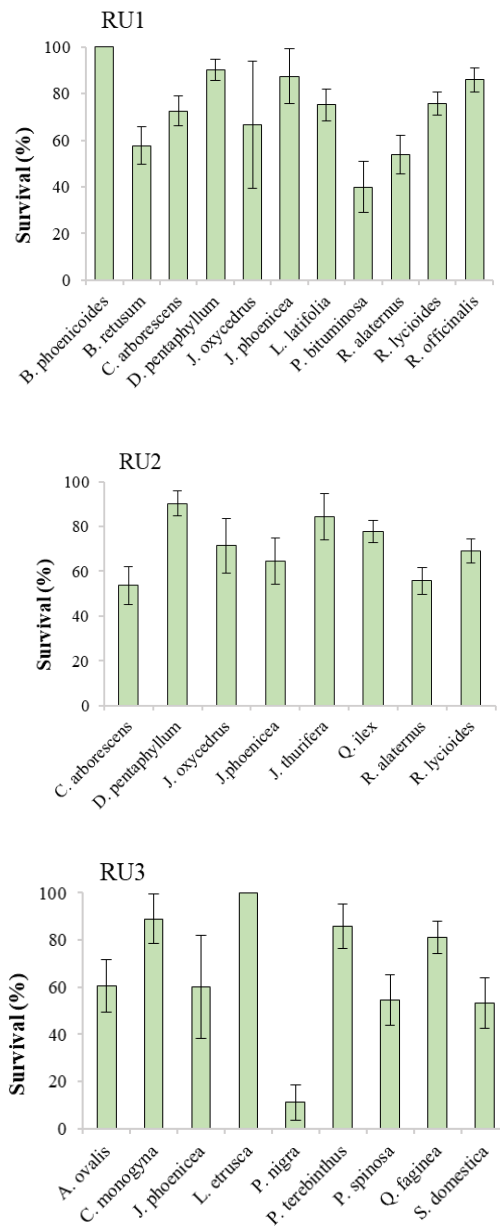
Among species, a 36% of species showed survival rates over 80%, and about 57% of species ranged between 50 and 80% of survival. The best performing species in survival were *Brachypodium phoenicoides*, *Dorycnium pentaphyllum*, *Juniperus phoenicea* and *Salvia rosmarinus* (before known as *Rosmarinus officinalis*) with survival rates higher than 85% (Fig. 3)

Fig 3. Survival rates (%) by species in the After-LIFE phase of the TECMINE project (June 2023) in each Restoration Unit: RU1 (left), RU2 (right) and RU3 (bottom). Values are means \pm SE.

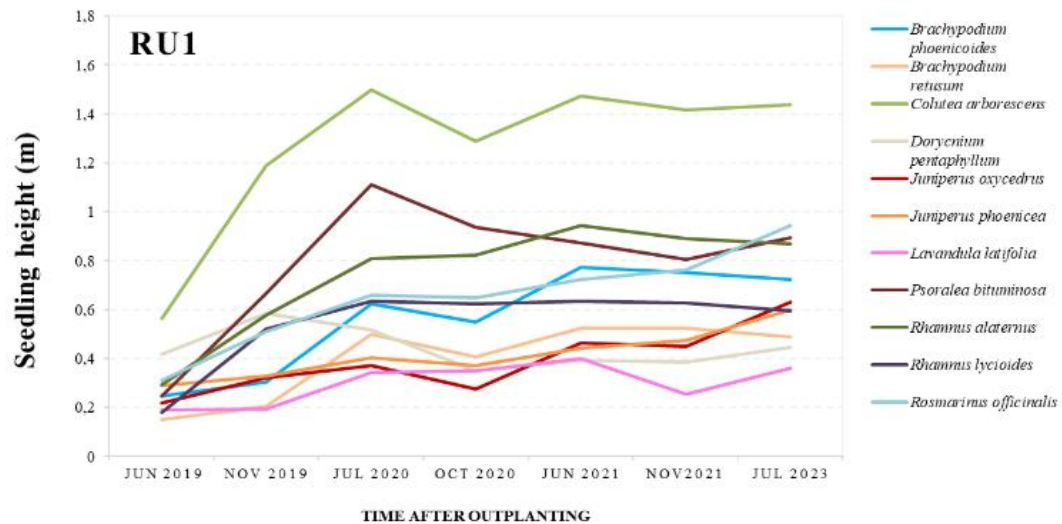
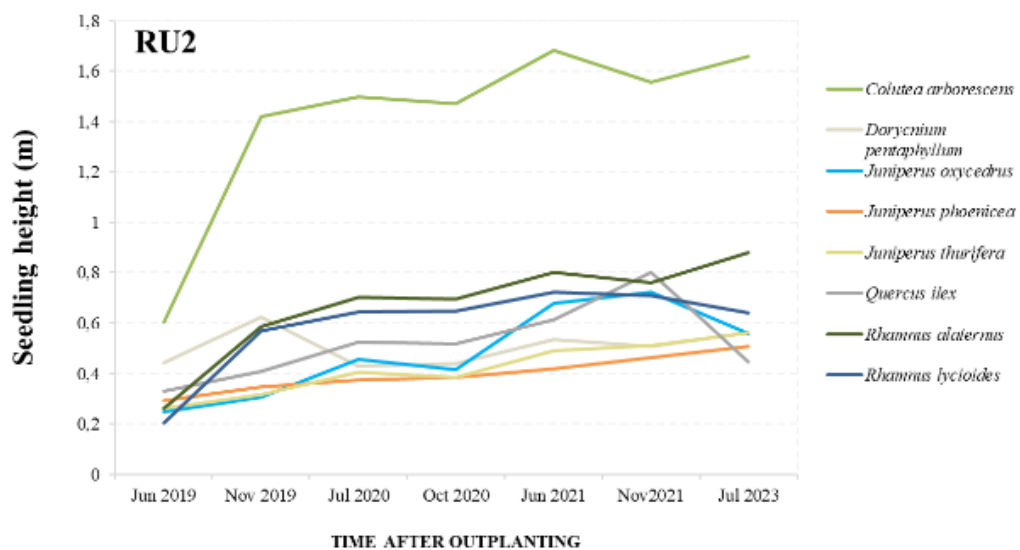
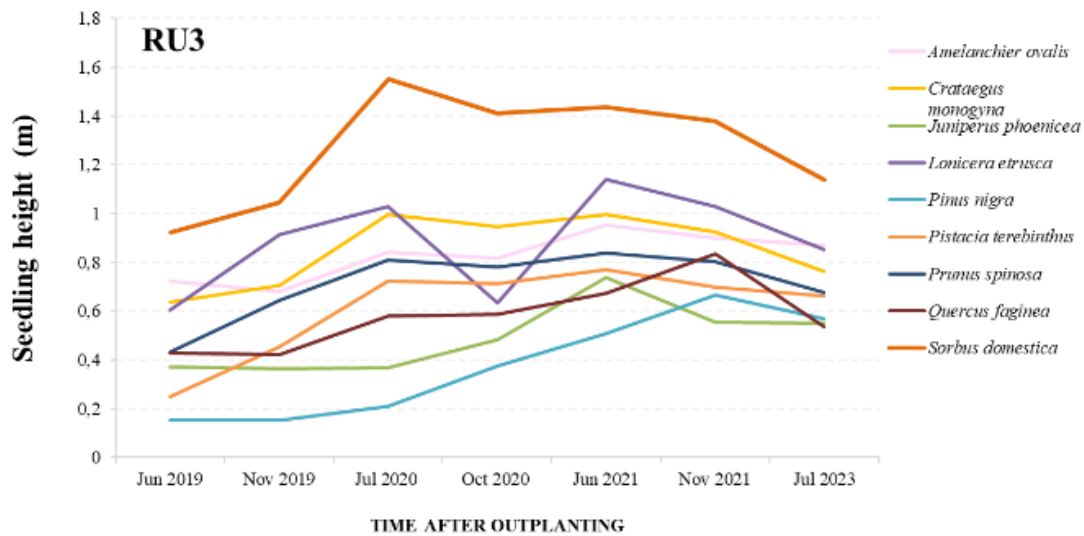
Seedlings growth was variable depending on the species and the RU restoration unit (Fig. 4). Some species such as *Colutea arborescens* or *Sorbus domestica* showed higher growth than the

rest of the species. In general, all species showed positive growth rates, however, some of them were specially affected by predation (by roe deer or wild pigs) showing slightly lower values than previous samplings.

Fig. 4. Average seedling height over time for each planted species. The period covers from the nursery to the After-LIFE survey (July 2023) for each Restoration Unit: RU1 (upper plot), RU2 (middle plot) and RU3 (lower plot).

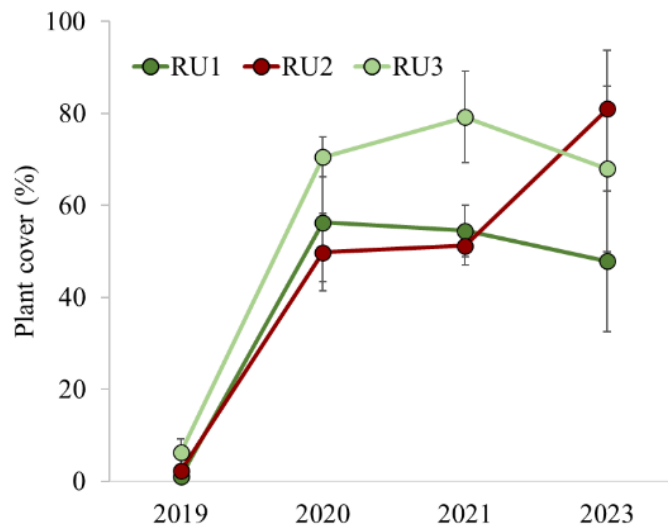
Vegetation cover in the three restoration units was around 66% on average. This meant a 4% increase in two years (from 2021 to 2023). This increment mainly corresponds to the plant cover found in the RU2, while the other two restoration units RU1 and RU3 decreased by 11% and 7% respectively (Fig. 5). Nevertheless, these small reductions in plan cover were very low and statistical test were not significant. In both cases, the restoration units RU1 and RU3 had similar decreasing trends possibly due to the high solar exposure for RU1 and the enlargement of a gully observed in situ in RU3 which belongs to the valley bottom area.

Fig 5. Plant cover (herbaceous + woody species) in each Restoration Unit: RU1 (upper plot), RU2 (middle plot) and RU3 (lower plot). Values represents means \pm SE.

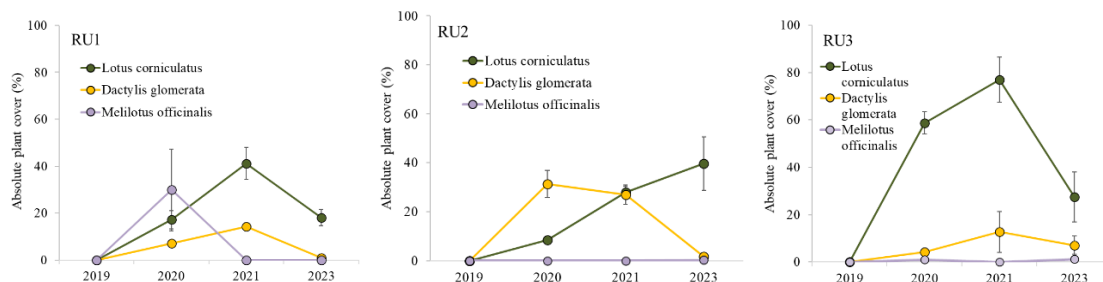
In relation to sown species for soil protection (*Lotus corniculatus*, *Melilotus officinalis* and *Dactylis glomerata*), the absolute plant cover significantly changed over time, depending on the species. In the last monitoring (July-23), their cover decreased considerably in all restoration units (Fig 6), which may have favoured the natural colonisation of native species.

Fig 6. Absolute plant cover of the sown herbaceous species (*Lotus corniculatus*, dark green; *Dactylis glomerata*, yellow; *Melilotus officinalis*, grey) during the different monitoring periods (2019, 2020, 2021 and 2023). Values are means \pm SE.

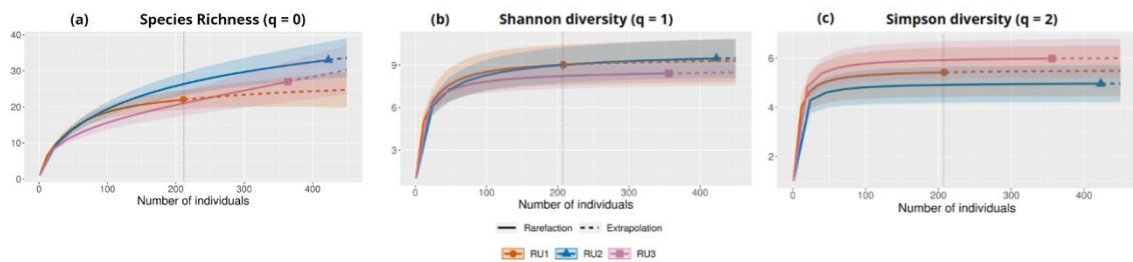
Regarding plant diversity, 20, 33 and 27 non introduced species were found within restoration units RU1, RU2 and RU3, respectively. Although diversity and species richness indices were higher in RU2 (Fig 7a, Fig 7b, Fig 7c) we did not find significant differences between restoration units (95% CIs overlap) which is positive as it was not intended to have differences between them.

Fig 7. Diversity indices. In the curves: rarefaction (solid lines) and extrapolation (dashed lines) and in the mark (triangle, circle or square) the number of individuals observed. (a) shows species richness in each area ($q=0$). (b) Shannon index ($q=1$) and (c) the Simpson index ($q=2$). (Orange circle = Restoration Unit RU1), (Blue triangle = Restoration Unit RU2), (Pink square = Restoration Unit RU3). The grey dashed vertical line indicates the number of individuals considered when assessing the indices.

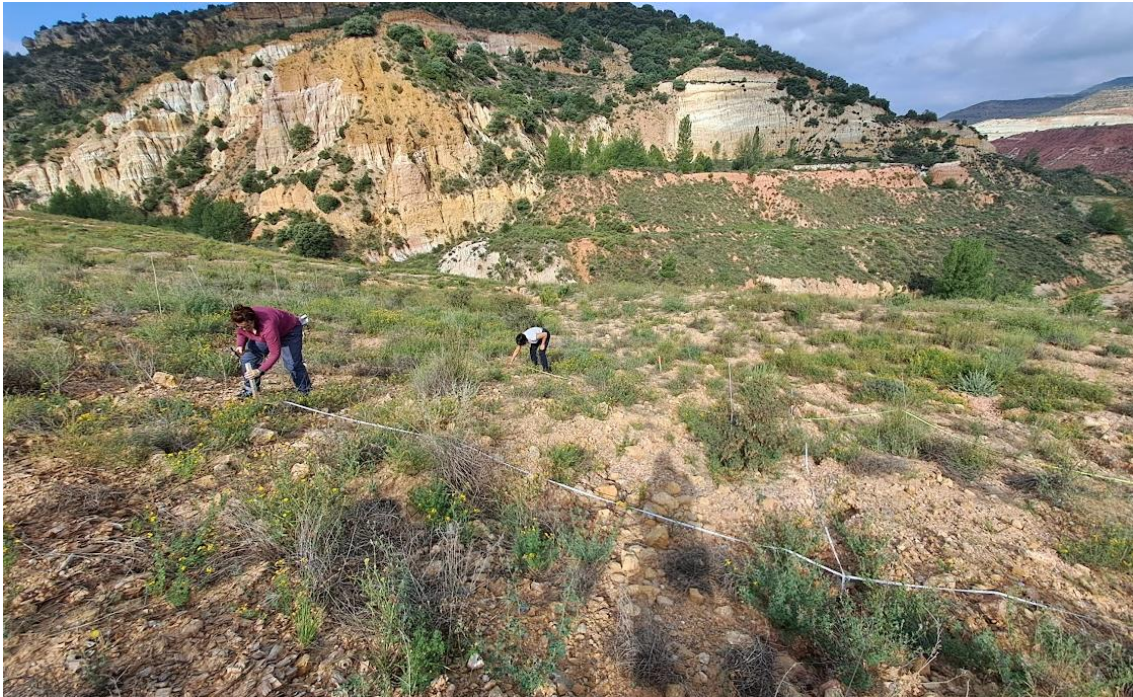
Fig. 1. General view of restoration unit RU1 during the After-LIFE monitoring (July-23). Plant cover in this unit is lower than in RU2 and RU3. However, we found high survival rates of introduced seedlings.

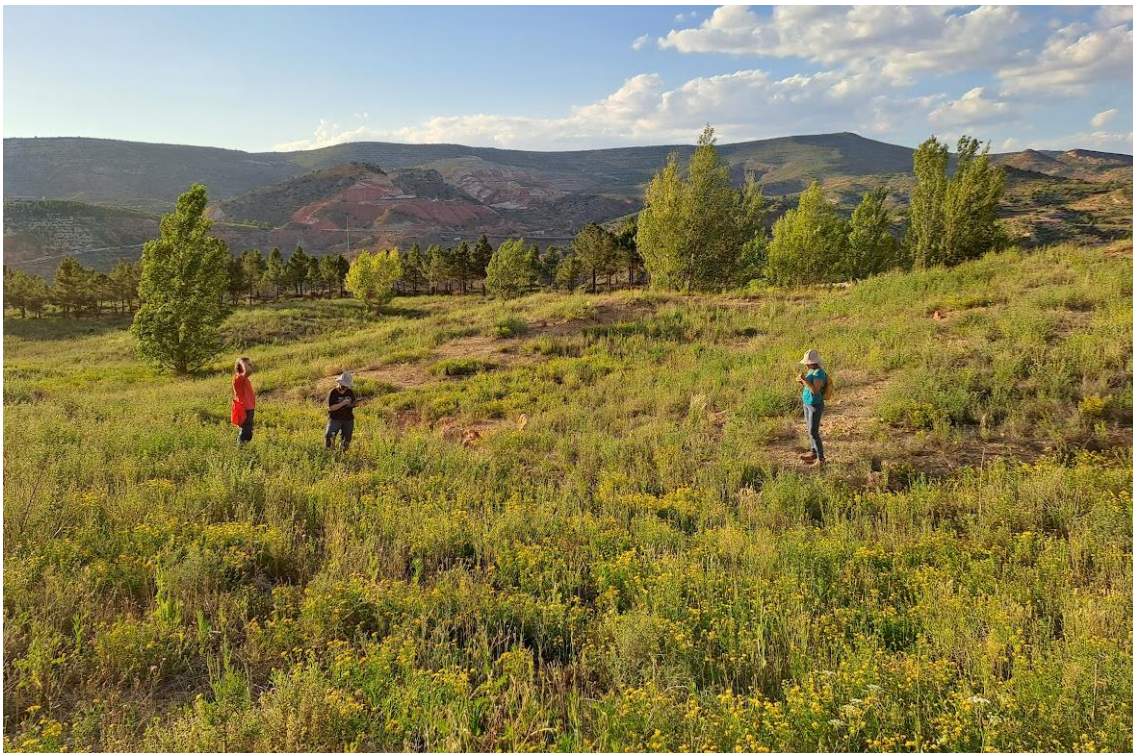
Fig. 2. General view of restoration unit RU2, with high degree of plant cover.

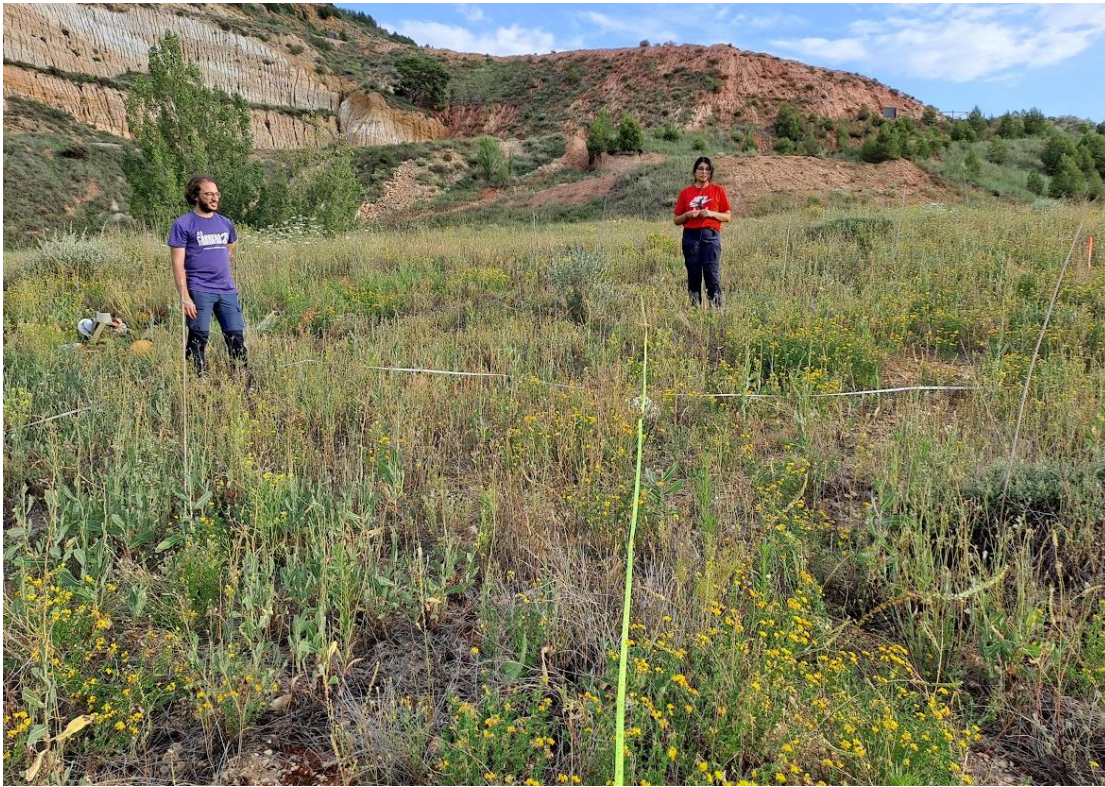
Fig. 3. Transects display in RU2. We assess every 20 cm soil cover, species richness and abundance.

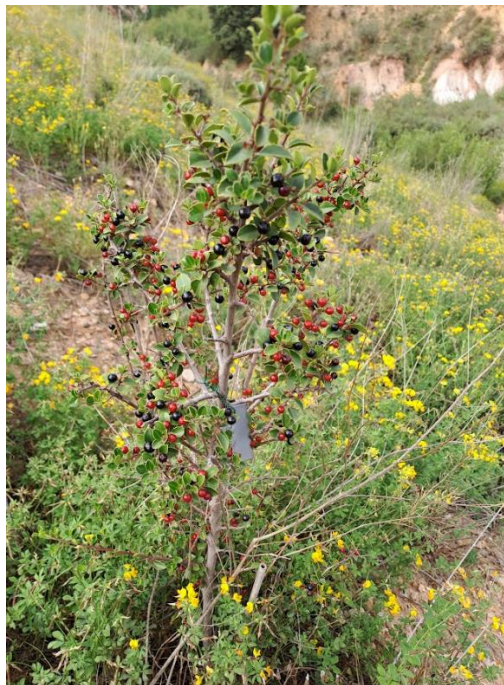
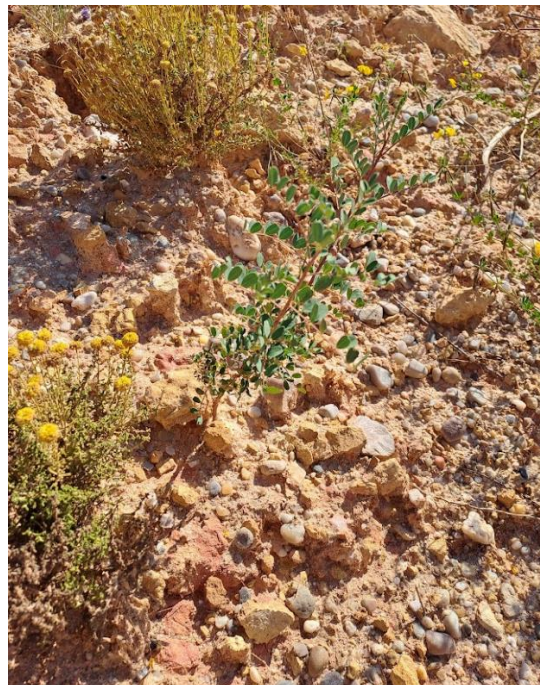
Fig. 4. Detailed image of *Rhamnus alaternus* fructification (left) and new recruitments of *Colutea arborescens* (right).

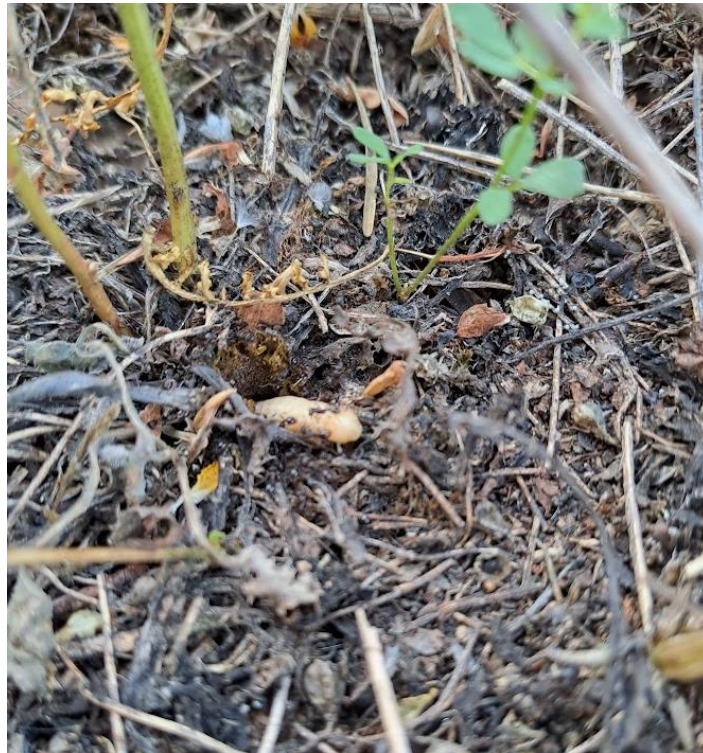
Fig. 5. Detailed image of soil cover under vegetation. 4.5 years after restoration, we found significant presence of organic matter and plant debris that are being incorporated into the soil, increasing fertility, and composing step by step a real soil that started from mining tails.
