Deliverable on establishment success of plantations: Survival and Growth

LIFE16 ENV/ES/000159

TECMINE After-LIFE. Action 1. MONITORING OF PLANT SURVIVAL AND GROWTH

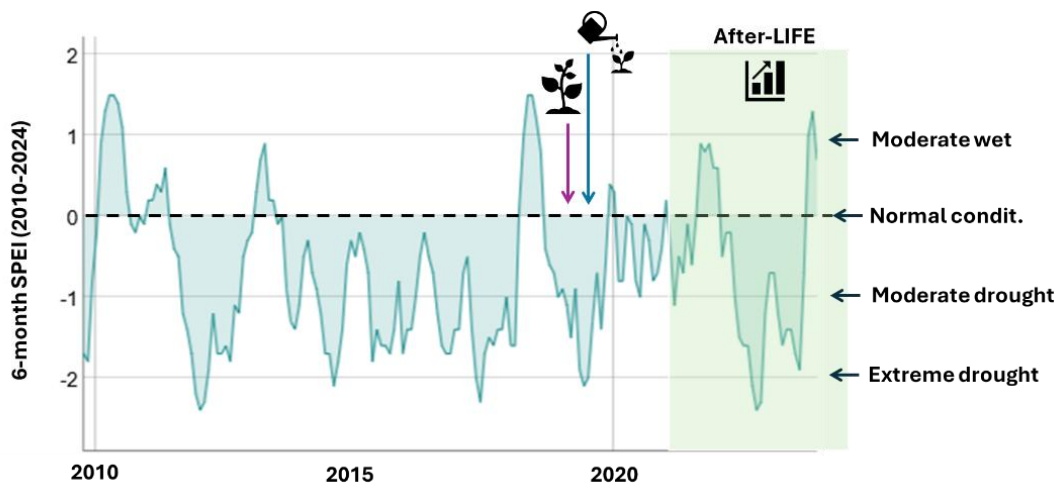
Figure 2. Evolution of 6-month SPEI index from 2010 to 2024, including plantation time (April-19) and the After-LIFE monitoring period (until 6 years after plantation).

To illustrate the degree of aridity in the restored area during the following years after restoration and relate it to the water stress experienced by plants during the six and a half years after plantation, we calculated the 6-month SPEI (Standardized Precipitation Evapotranspiration Index; Fig. 2) through the openly available CSIC website (https://spei.csic.es/spei_database). This SPEI-time scale effectively captures moisture conditions at seasonal level, such as the summer droughts or the growing seasons, which can correlate with the success or failure of restored plants.

Right after plantation (April-19) the area experienced an extended and severe drought-period (SPEI < -1.5) that conditioned the implementation of an emergency watering. Fortunately, the irrigation applied during the early stages after plantation ensured enough soil water content for plants uptake, and the following years, until 2022, the water availability conditions were good enough to allow root development and plant establishment. During the After-LIFE, nevertheless, especially during 2023 and part of 2024, the aridity conditions reached even SPEI values significantly lower than -2, which is considered extreme aridity conditions. These harsh water availability conditions greatly limited plant growth rates. Surprisingly, survival rates remained almost stable during the After-LIFE period (see survival data below).

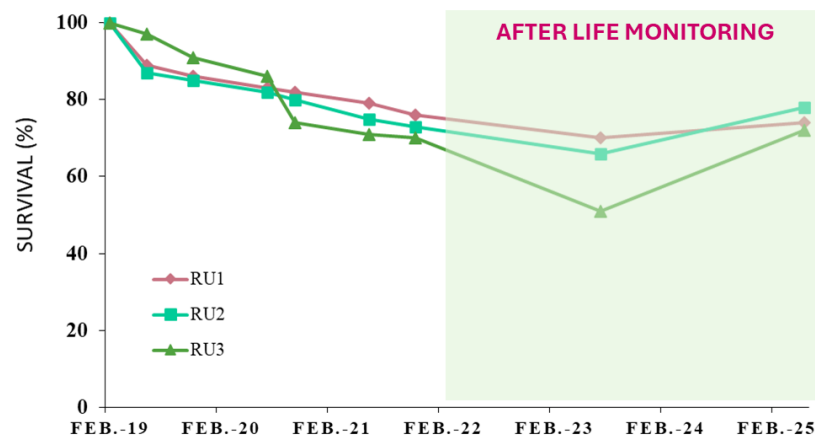
Figure 4. Survival dynamics across time in the restored area (Geofluv West area) of the TECMINE project for each Restoration Unit: dark pink-diamonds=RU1; light green-square=RU2; grey- triangle= RU3.

Despite the limiting abiotic conditions during the After-LIFE period, average survival rates of the introduced seedlings in the last field sampling (2025), was around 75%. Regarding each restoration unit: final survival rates were 74%, 78% and 72% for RU1, RU2 and RU3, respectively. The results after 6.5 years showed high survival rates and an overall restoration success (Fig. 4).

According to the figure 4, in the survival campaign in 2023 we detected a slightly decrease in survival rates in RU1 and RU2. This drop was especially notable for plants introduced in RU3. This artefact could be attributed to the resprouting capacity of many of the introduced species, that dried out the leaves and the above ground biomass during the extremely drought 2023 and recover from roots when soil water conditions enhanced. Furthermore, some of the metallic labels used to taggle the plants were lost after more than 6 years, especially in plants from RU3. Thus, the number of individuals sampled 2025 could have slightly varied from the previous field surveys.

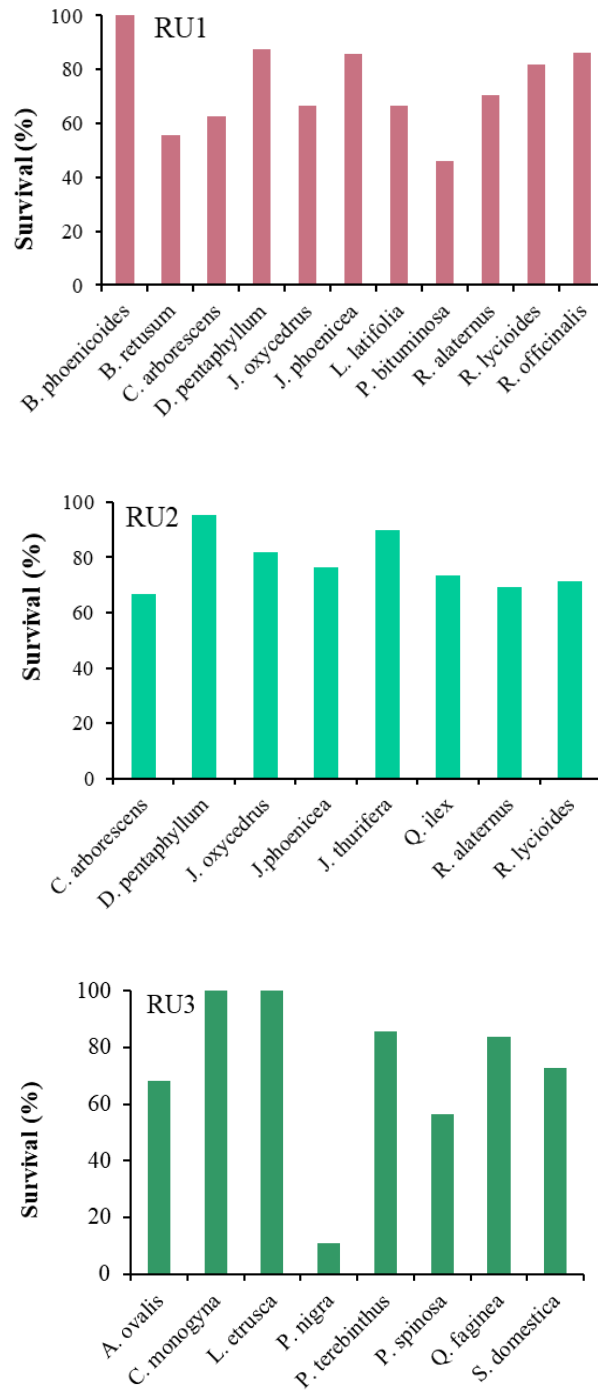
Figure 5. Survival rates (%) by species at the end of the After-LIFE monitoring of the TECMINE project (May 2025) in each Restoration Unit: RU1 , RU2and RU3 .

Among species, the best performing species in survival were *Brachypodium phoenicoides*, *Dorycnium pentaphyllum*, and *Salvia rosmarinus* (former *Rosmarinus officinalis*) in RU1, *Juniperus phoenicea* in RU2, and *Lonicera etrusca* and *Crataegus monogyna*, all of them with survival rates above 90% (Fig. 5). Oppositely, the species that clearly performed below our expectations was *Pinus nigra*, in RU3, that had very poor plant-quality conditions from the nursery. This supposed survival rates below 20%. Additionally, *Psoralea bituminosa*, in RU1, neither accomplished fully successful expectations with survival rates between 40 and 50% as consequence of 2023 drought (Fig. 5).

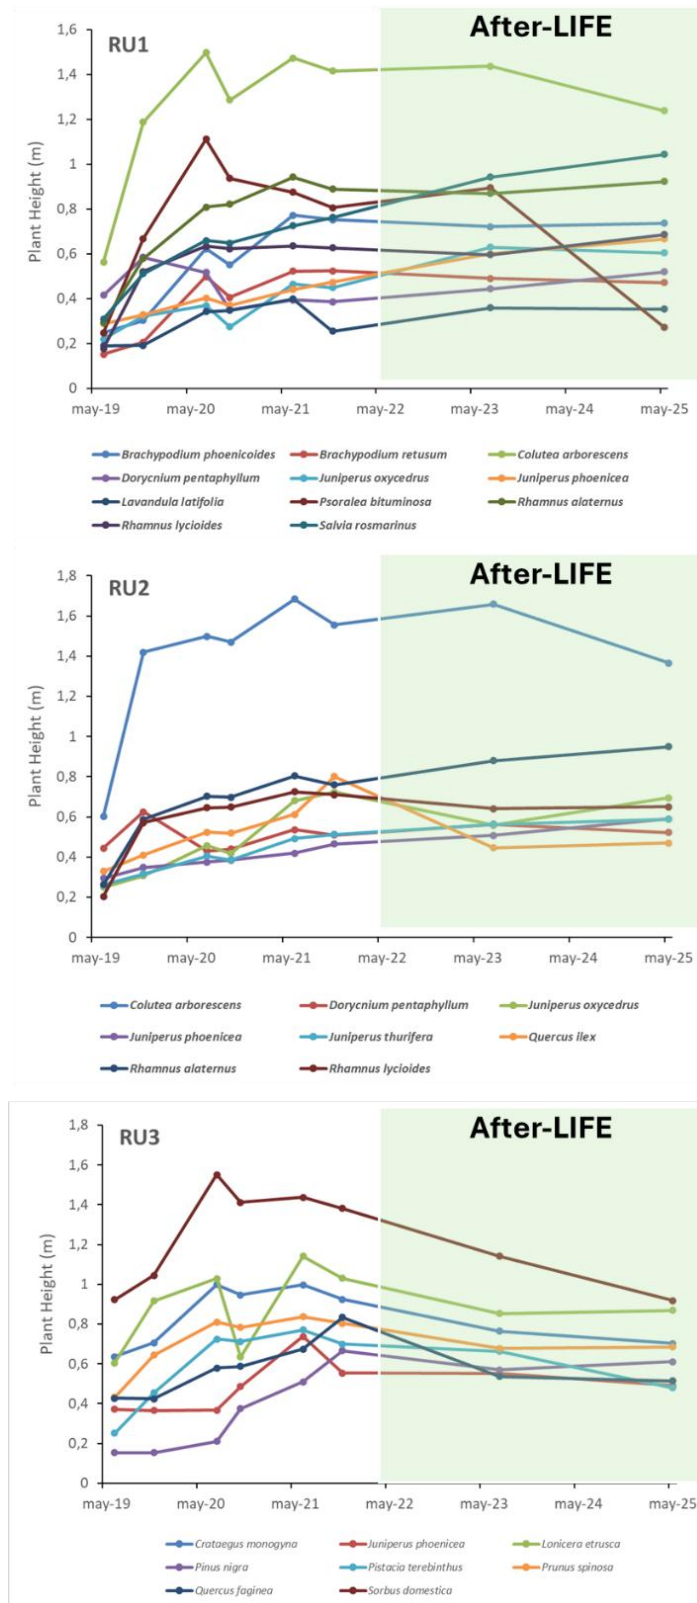
Figure 6. Average seedling height over time for each planted species. The period covers from the nursery to the After-LIFE survey (July 2023) for each Restoration Unit: RU1, RU2 and RU3.

Seedlings growth rates were in general low. Species growth rates were affected by both abiotic and biotic factors. In the one hand, regarding abiotic factors, some species were especially affected by the low water availability during 2023. Thus, the growth rates were variable depending on the species and the RU restoration unit (Fig. 6). Some species such as *Colutea arborescens* or *Sorbus domestica* showed higher growth than the rest of the species. In the other hand, some other species were specially affected by predation (by roe deer or wild boars) showing slightly lower values than previous samplings. This damage was specially marked in species such as *Sorbus domestica*, *Quercus ilex* and *Rhamnus alaternus*.

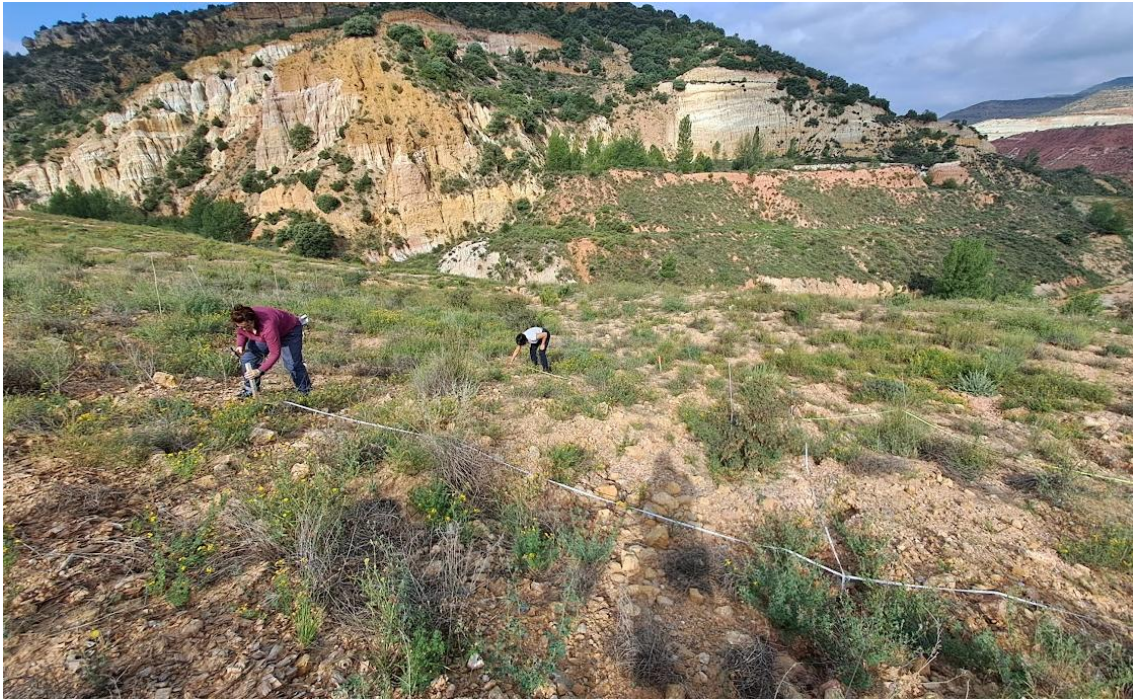
Figure S1. General view of restoration unit RU1 during the After-LIFE monitoring (July-23). Plant cover in this unit is lower than in RU2 and RU3. However, we found high survival rates of introduced seedlings.

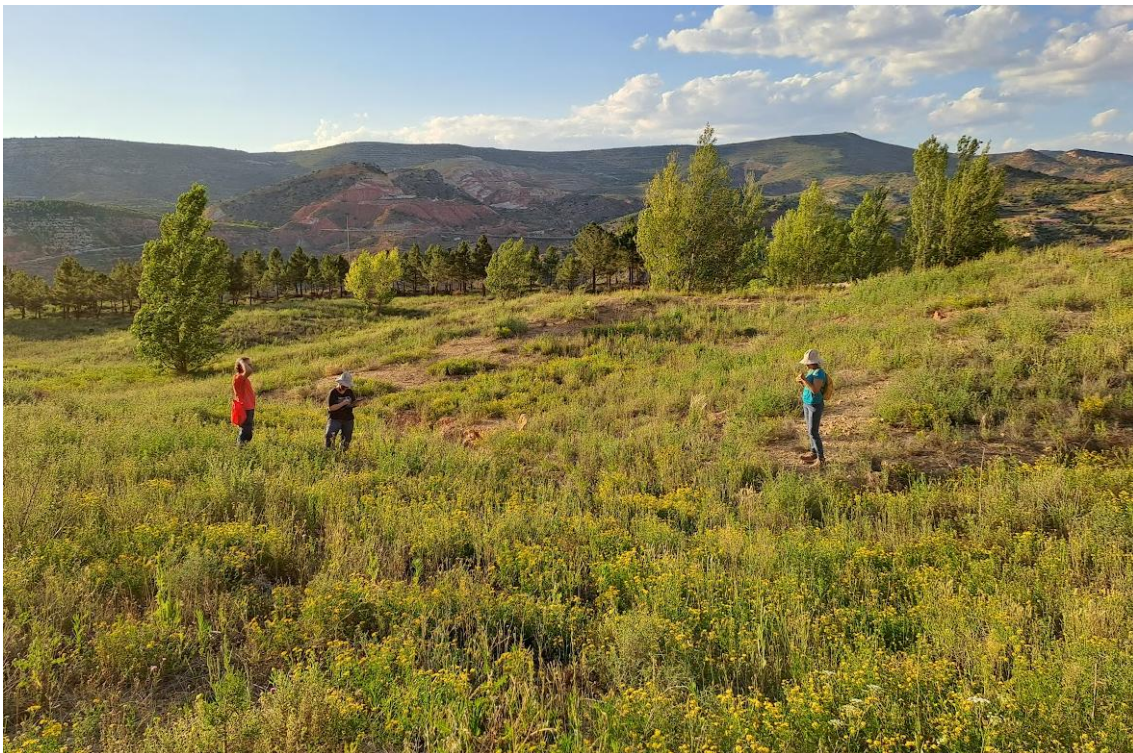
Figure S2. General view of restoration unit RU2 (July 2023), with high degree of plant cover.

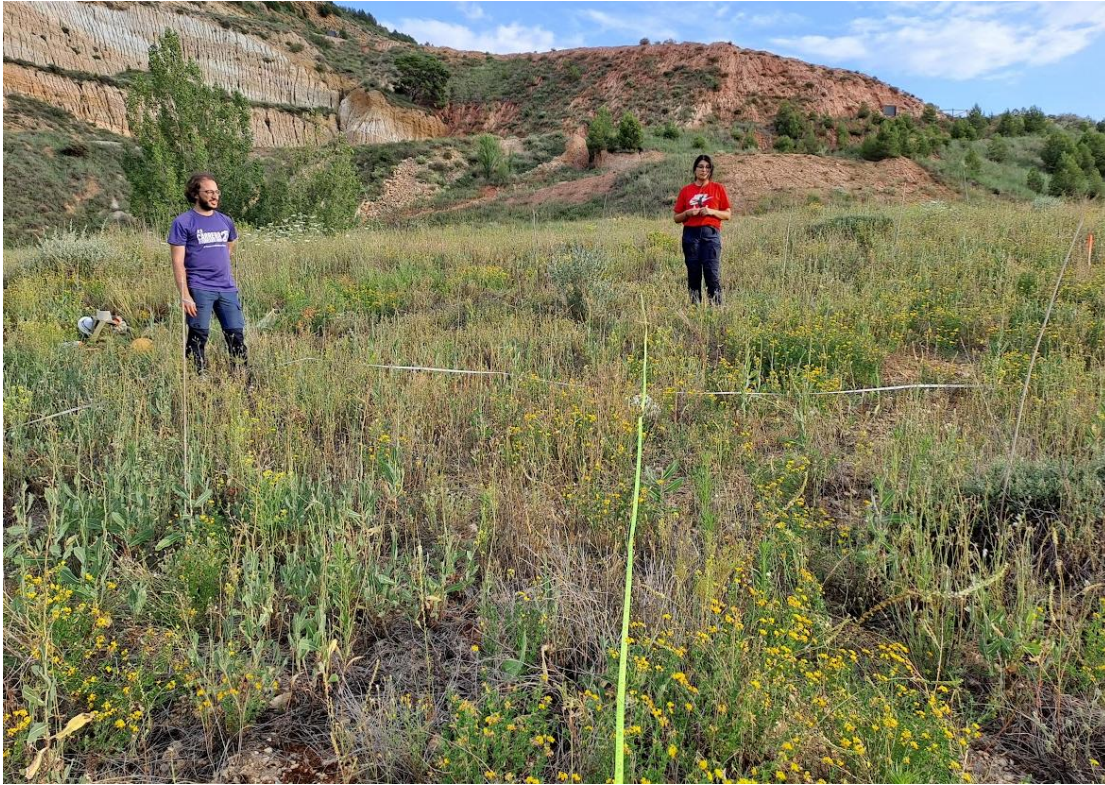
Figure S3. Transects display in RU2. We assess every 20 cm soil cover, species richness and abundance.

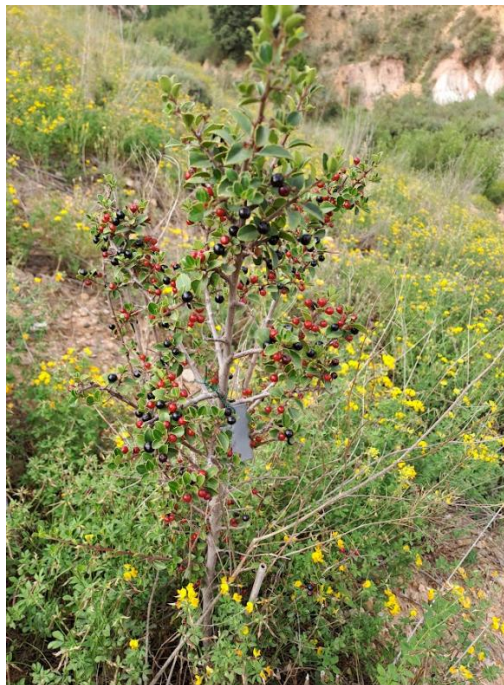
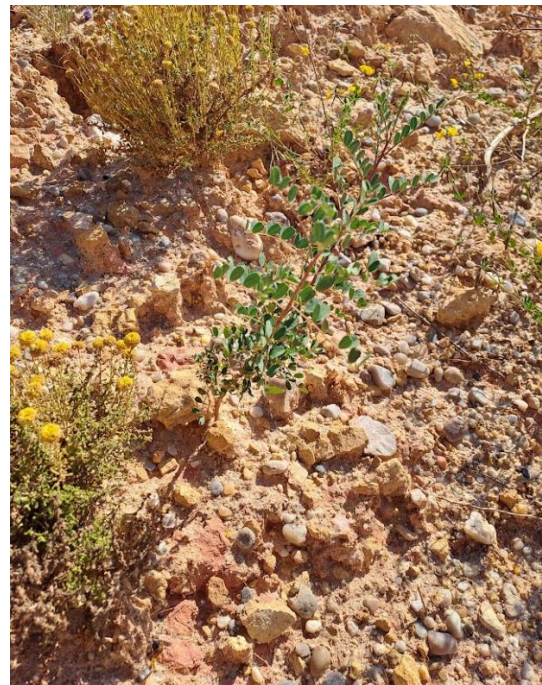
Figure S4. Detailed image of *Rhamnus alaternus* fructification (left) and new recruitments of *Colutea arborescens* (right).

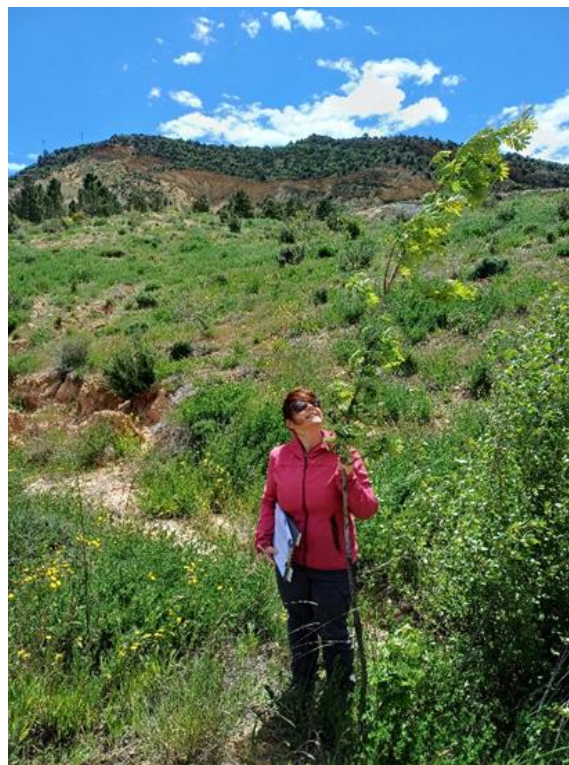
Figure S6. Example of *Sorbus domestica* with good growth in RU-3 by June 2025 (6.5 years after plantation).

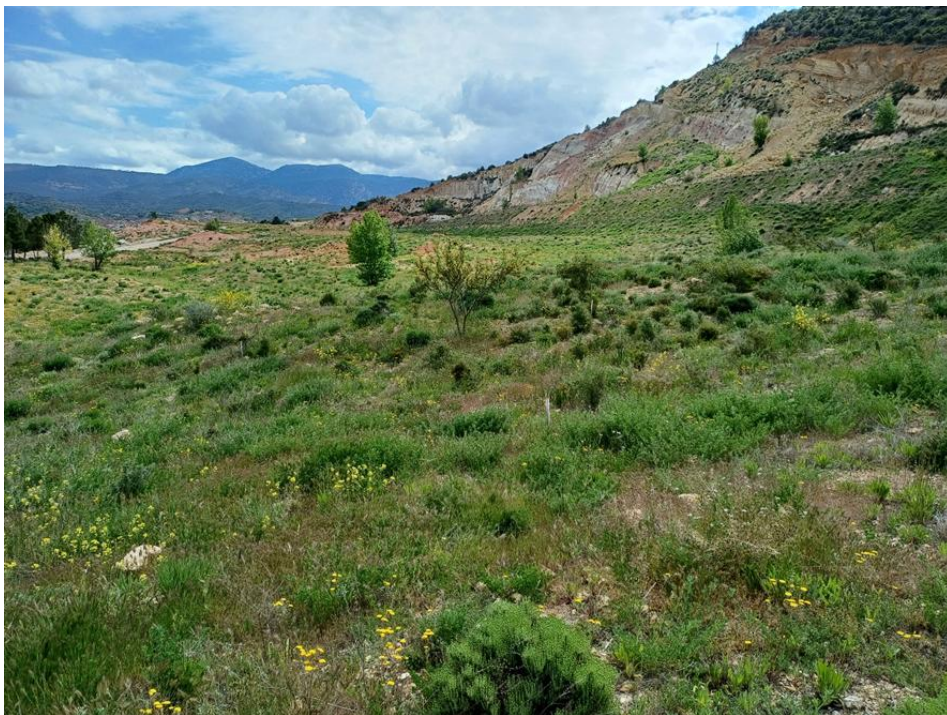
Figure S9. General view of the RU-2 by June 2025. Note that introduced *Lotus corniculatus* has almost disappeared and other herbaceous species such as *Bromus* sp. are currently dominant. It can also be appreciated the high diversity of plant morphotypes indicating a high diversity of species.

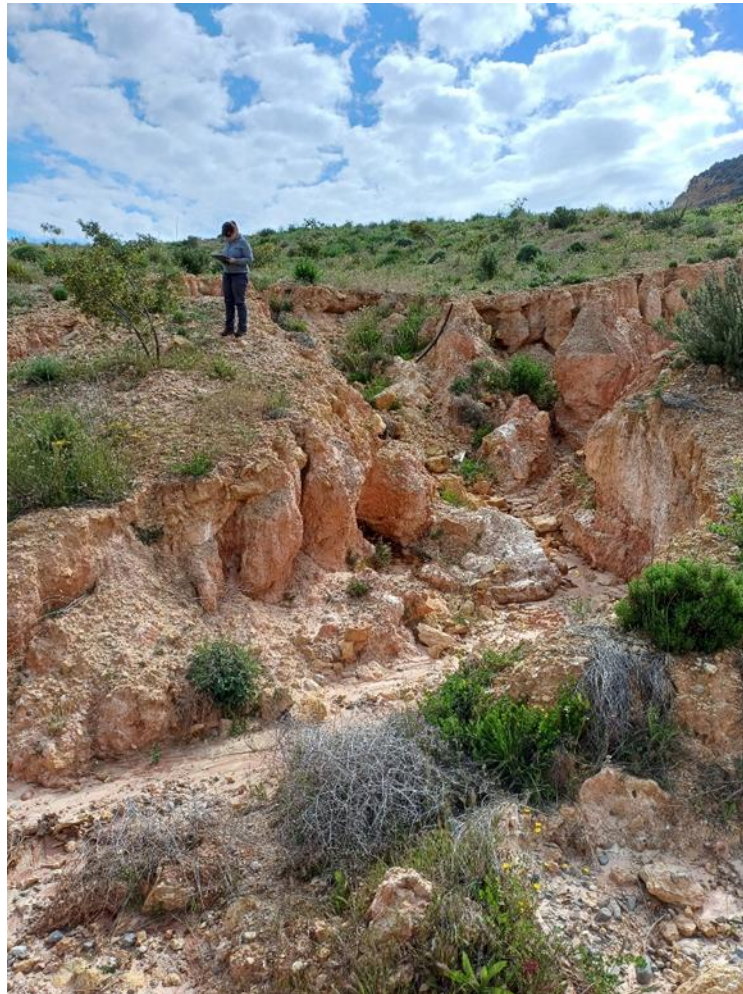
Figure S10. Big gully developed in the RU-1 because of flow concentration from upper parts of this unit. This highlights the relevance of creating a good geomorphological design avoiding steep slopes and promoting materials and textures in the soil surface to favor soil infiltration.
